# TEST REPORT

## FL100 Composite Cover and Frame BS EN124 C250 Test

Document reference number - FIB-FL100-19-01-16

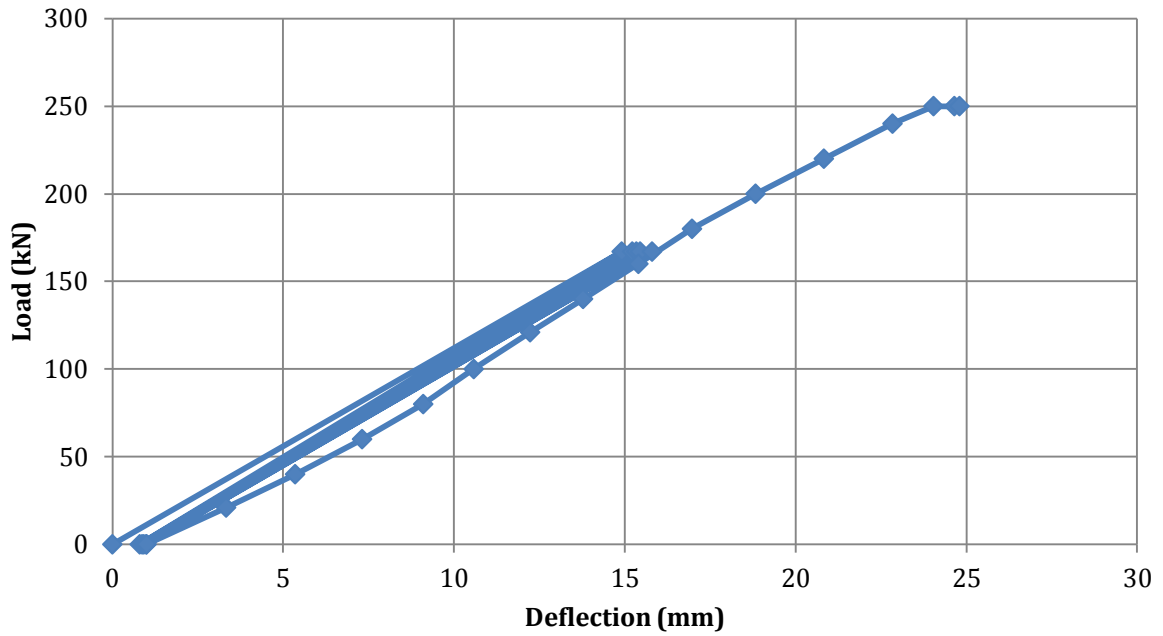
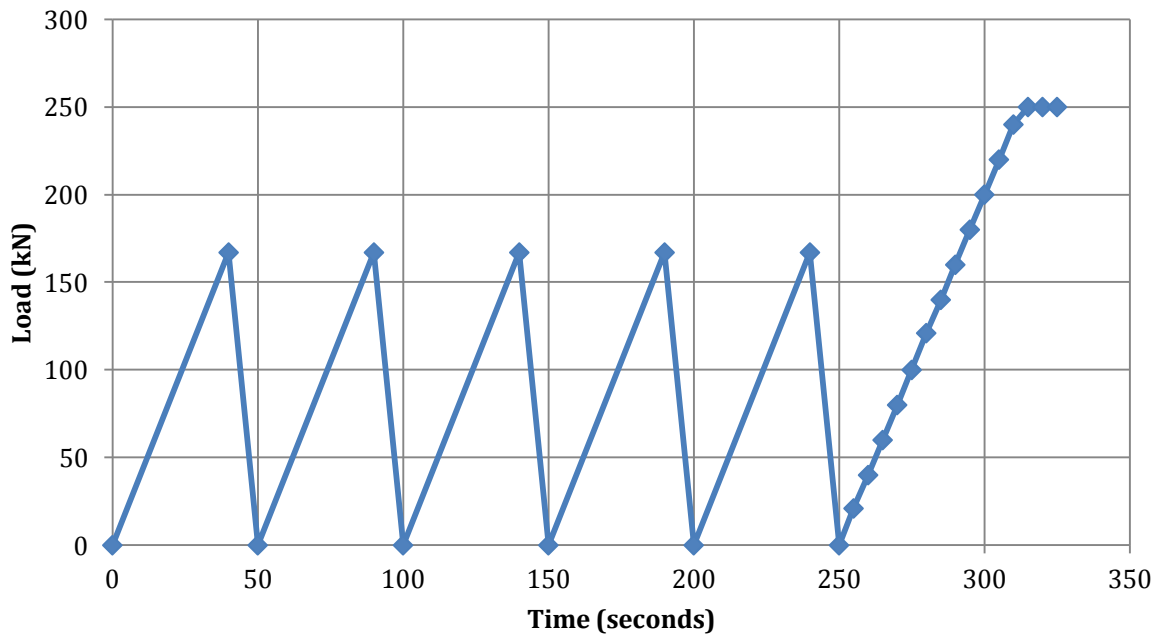
### FL100 EN124 C250 Test

**The cover held the test load of 250kN for the required 30 seconds.**

**In accordance with EN124 Clause 8.3.1 the permanent set of the cover was 1.00mm which is within the permissible stated in Table 8 of the standard. ( $1/300 \times 1000 = 3.33\text{mm}$ ).**

**The cover therefore passed the EN124 C250 test for both permanent set and load.**

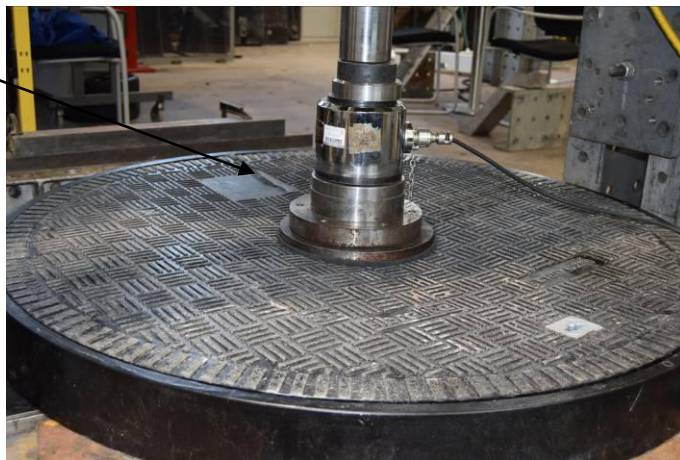
Photo.3

After the cover had passed the C250 load test the load was removed and the cover inspected. The dial gauge was removed to avoid damage and the cover then reloaded until failure occurred at 357kN.

Photograph 3 below shows the cover still in the test rig at failure showing the crack that appeared on the top face.

Crack
