## **TEST REPORT**

### **FL100 EN124 D400 Cover Test**

Date: 12/09/12

**Client: Fibrelite Composites Ltd.**

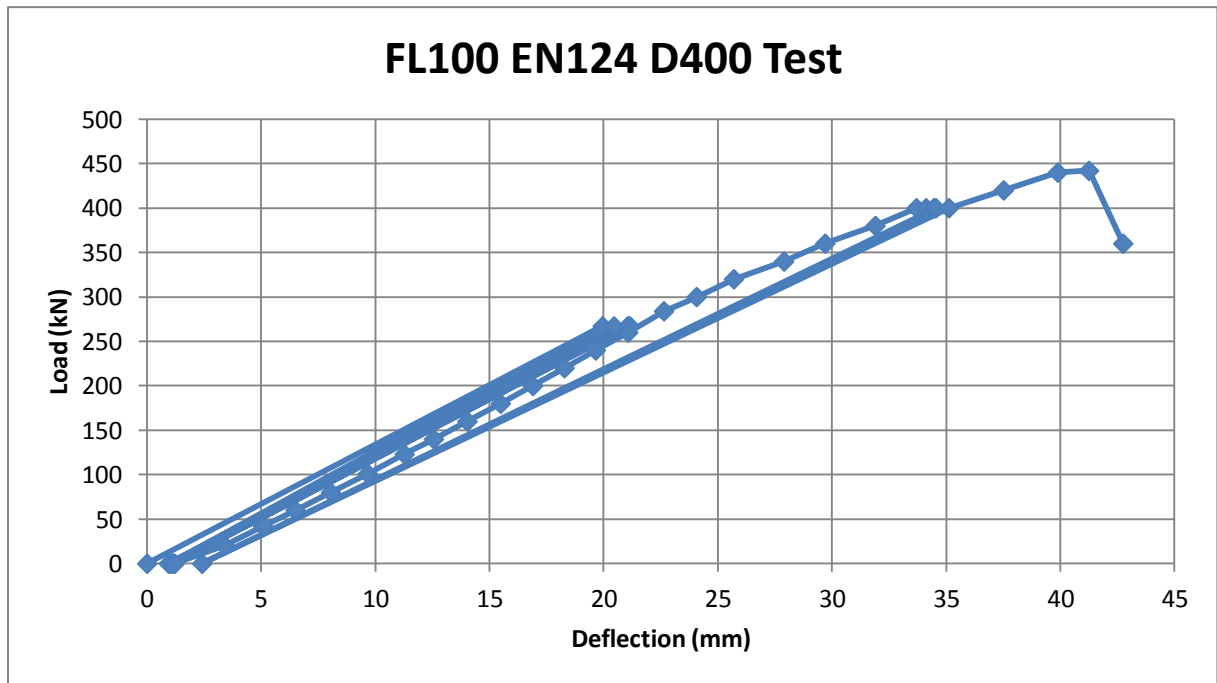
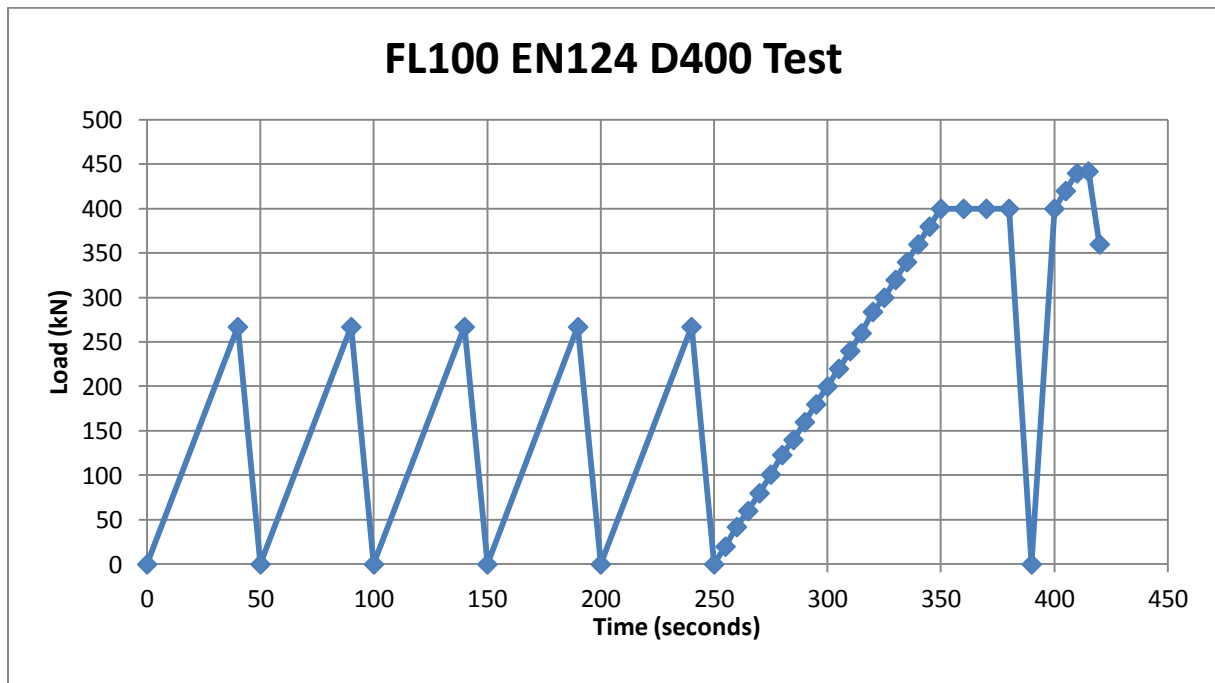
**The cover held the test load of 400kN for the required 30 seconds so therefore passed the EN124 D400 test.**

**In accordance with EN124 Clause 8.3.1 the permanent set of the cover was 1.21mm which is within the permissible stated in Table 8 of the standard. ( $1/300 \times 1000 = 3.33\text{mm}$ ).**

**After the cover had passed the EN124 D400 test, the load was released from the 400kN and after waiting two minutes for the cover to settle, the permanent set was recorded at 2.41mm**

**The cover was then loaded again until failure at 442kN**

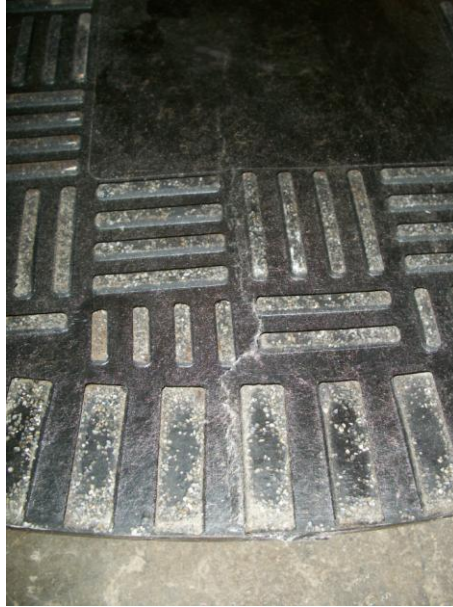
Photo.3

On the top surface there was a large crack running from the outside edge of the cover towards the centre. (Photo.3)

There were no signs of any cracking to the bottom surface of the cover or any damage to the frame.
