TEST REPORT

FL180 EN124 C250 Cover Test

Date: 22/03/13

Client: Fibrelite Composites Ltd.

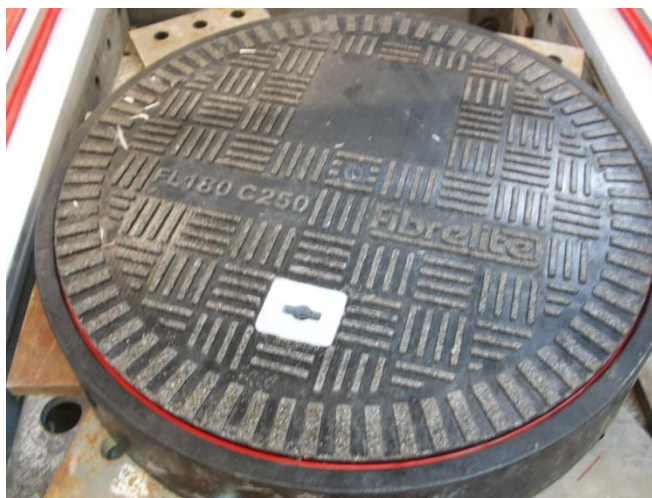
Photo. 1

The cover supplied is a round FL180 and of composite construction with an overall diameter of 540mm and a depth of 100mm. (See photo. 1)
No. on cover – 2922

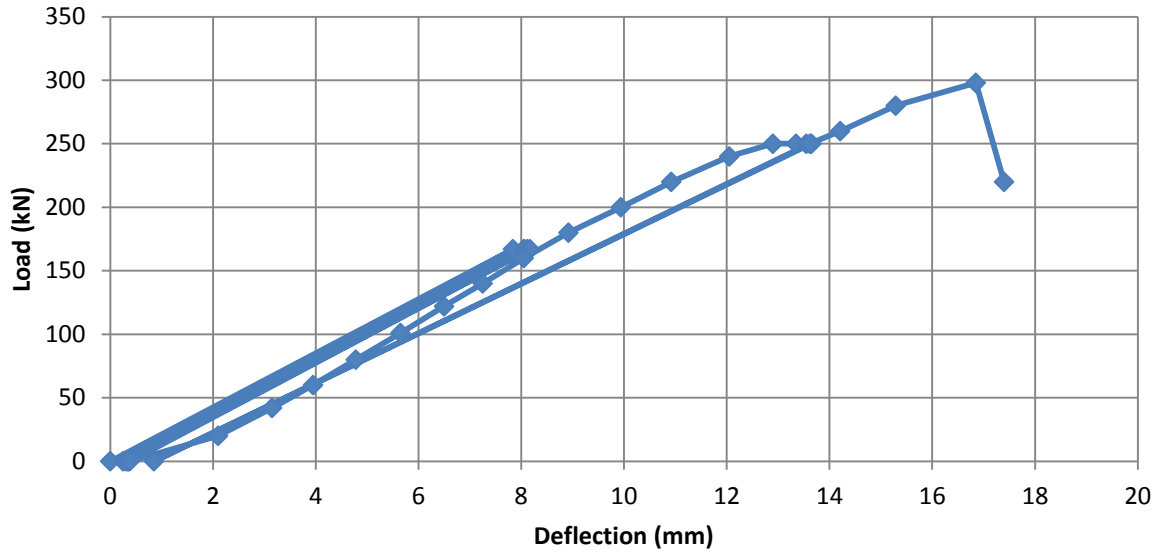
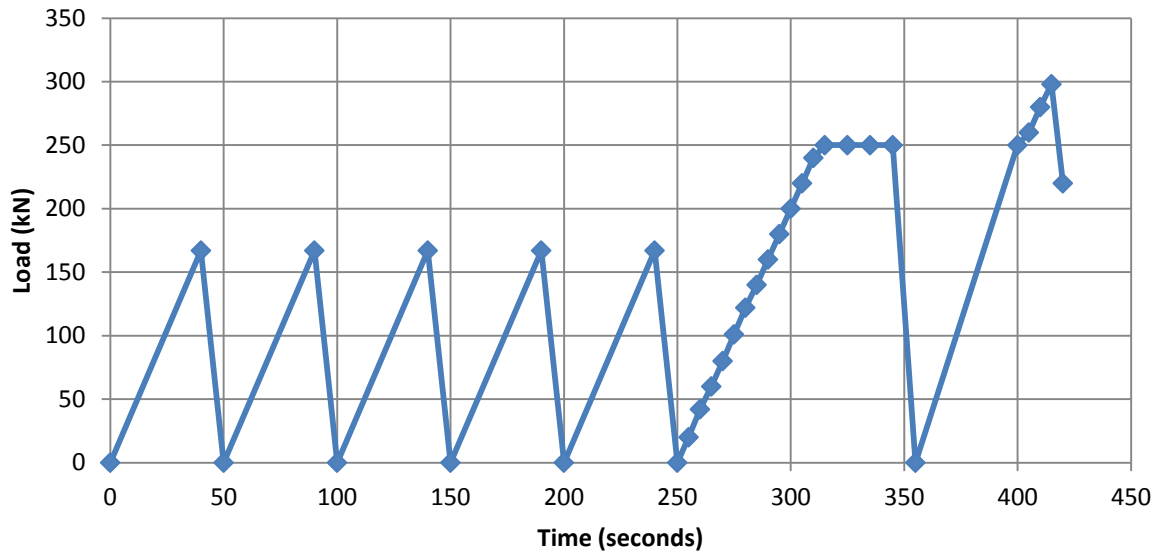
FL180 EN124 C250 Test

The cover held the test load of 250kN for the required 30 seconds so therefore passed the EN124 C250 test.

In accordance with EN124 Clause 8.3.1 the permanent set of the cover was 0.38mm which is within the permissible stated in Table 8 of the standard. ($1/300 \times 458 = 1.53\text{mm}$).

The cover therefore passed the permanent set test also.

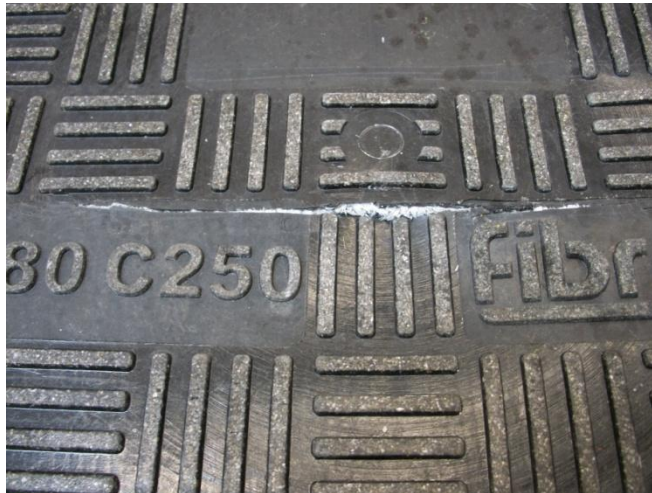
Photo.3

After the cover had failed at 298kN it was removed from the test rig and inspected for damage.

On the top face a large crack had developed about 230mm long and 30mm from the centre of the cover. (Photo.3)

There were no visible signs of any damage to the bottom surface of the cover or to the frame.
