## **TEST REPORT**

### **FL180 B125 Cover Test**

**Client: Fibrelite Composites Ltd.**

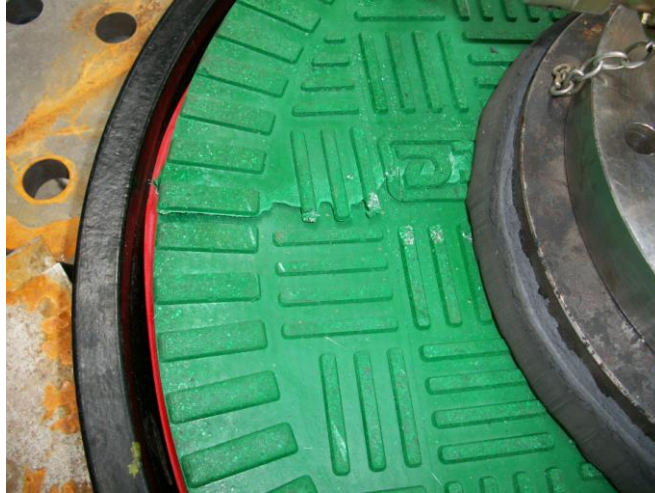
Photo.3

**The cover failed at 202kN.**

Photograph 3 shows the cover still in the test rig under load at failure and a large crack running halfway across the cover from the edge to near the centre.

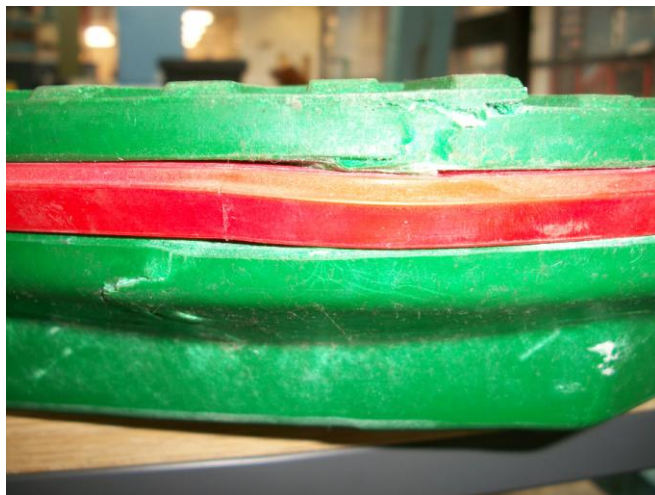
Photo.4

Photograph 4 shows the crack running through the depth of the cover.

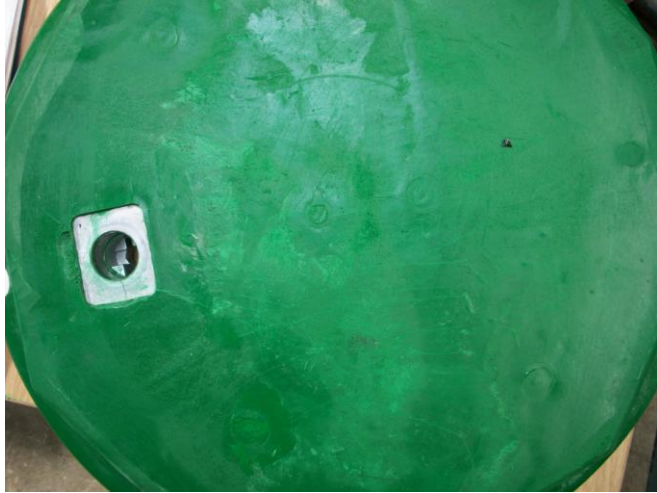
Photo.5

The bottom surface of the cover showed some permanent deformation and some light cracking to the resin. (Photo.5)
