## **TEST REPORT**

### **FL60 Cover Test to EN124 C250**

Date: 19/06/09

**Client: Fibrelite Composites Ltd.**

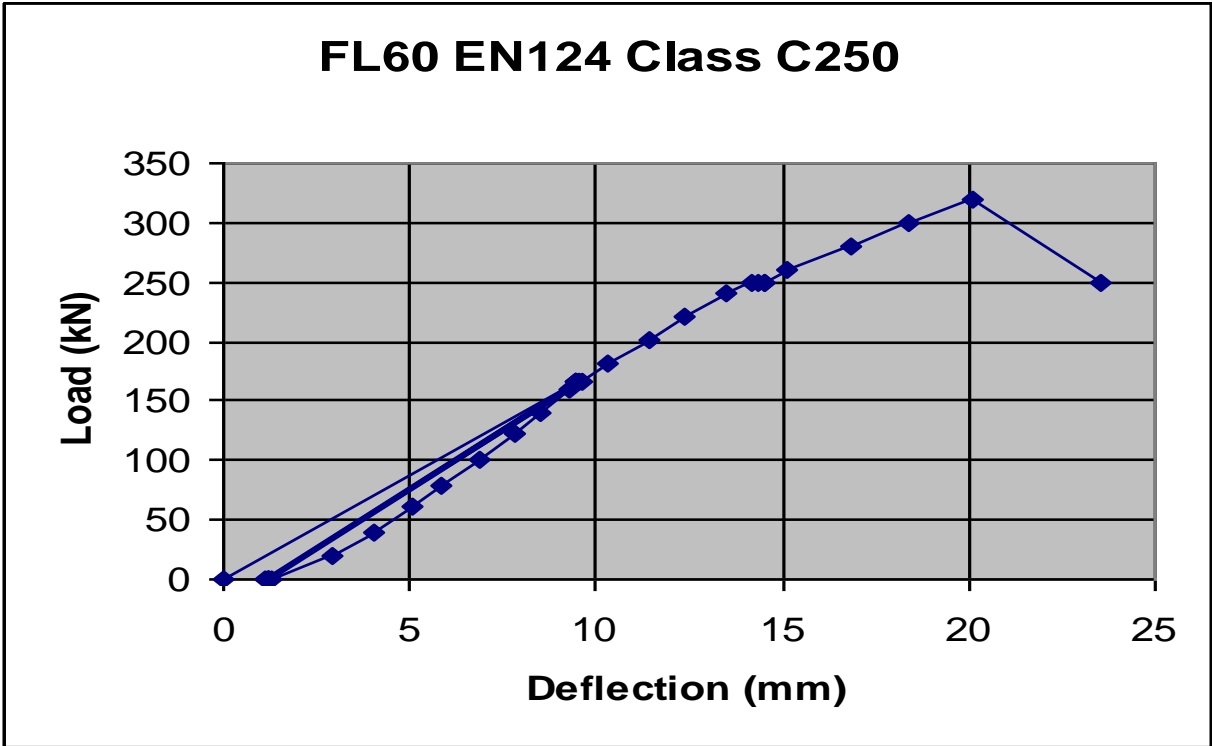
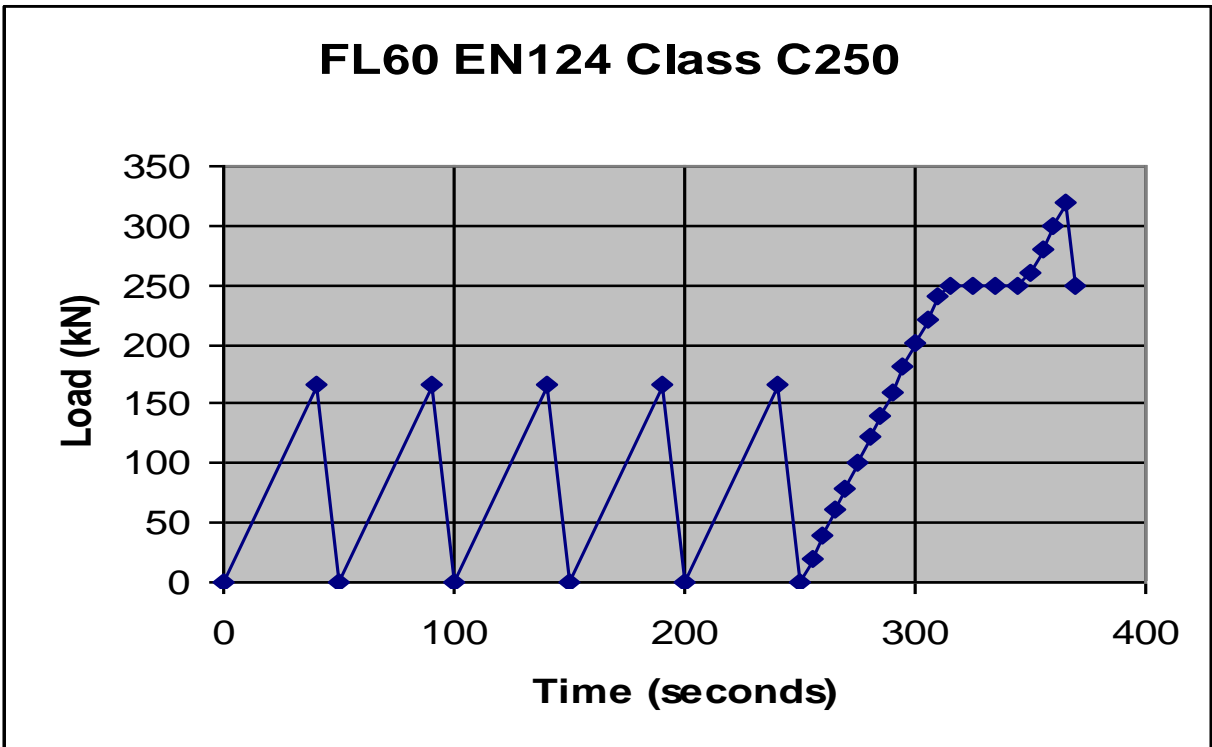
**In accordance with EN124 Clause 8.3.1 the permanent set of the cover was 1.28mm which is within the permissible stated in Table 8 of the standard. ( $1/300 \times 600 = 2.00\text{mm}$ ).**

**The cover held the test load of 250kN for the required 30 seconds and therefore passed the EN124 C250 test.**

Light cracking noises were heard from about 30kN getting louder and more significant by 280kN

At 320kN the cover failed with a number of loud cracks and bangs.

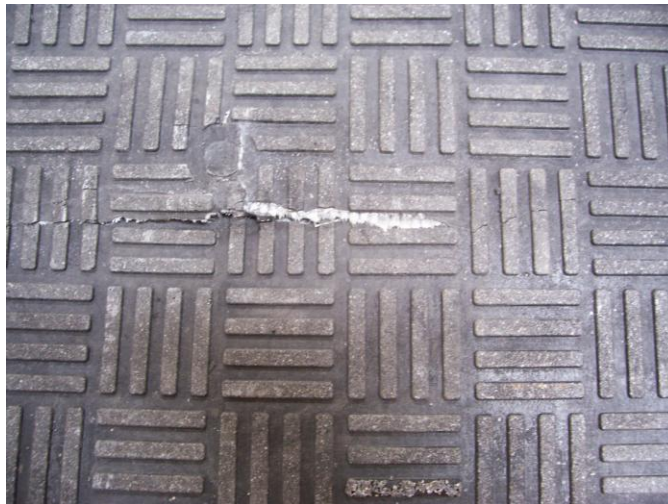
Photo.3

On the top surface there was a large crack/split near the centre running across the cover and down the edge. (See photos 3 & 4)
