# TEST REPORT

## FL600/D400 Composite Cover and Frame BS EN124 D400 Test

Document reference number - FIB-FL600-13-05-15

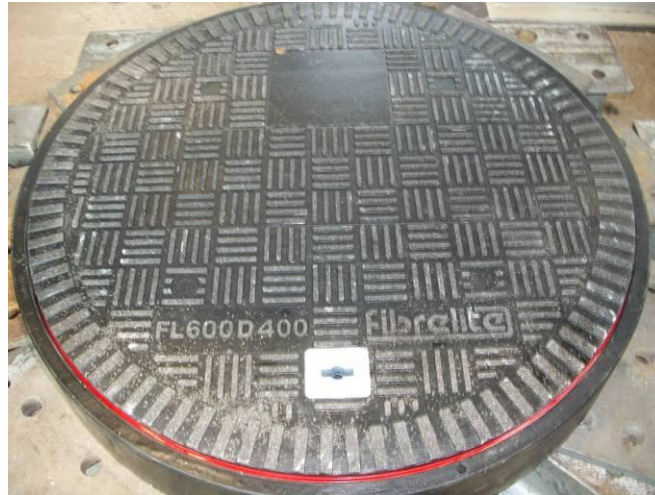
Photo. 1

The composite cover supplied is a round FL600/D400 complete with frame. (Photo.1)

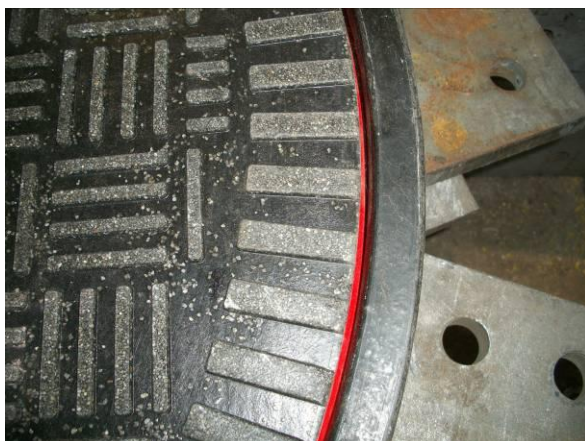
Photo.3

Below photograph 3 shows the gap that appeared between the edge of the cover and frame by the two thirds test load of 267kN.

The gap was about 5mm at either side whilst photograph 4 shows no gap, this was at the front and back edge as you look at the test rig.

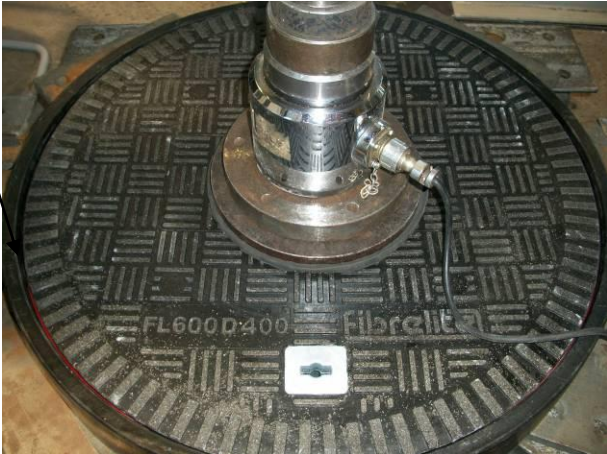
Photo.5

The cover was then loaded further until ultimate failure occurred at 421kN.

Photograph 5 now shows the cover and frame at the failure load of 421kN.

10mm gap and cover sunk in  
15mm from top edge of frame

No gap

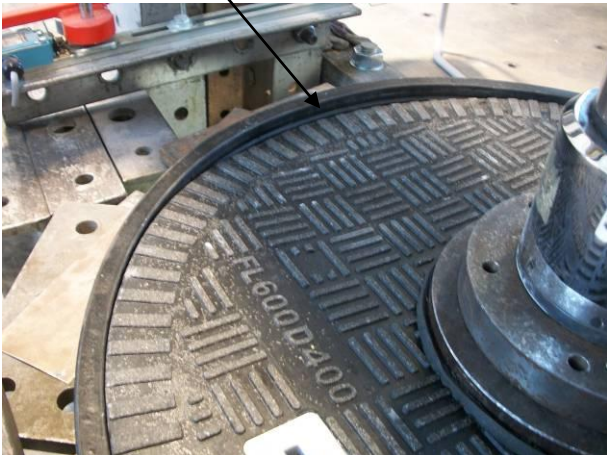
Photo.6

Photograph 6 shows a close up of the depressed cover.
