TEST REPORT

FL600/D400 Composite Cover and Frame BS EN124 D400 Test

Document reference number - FIB-FL600-13-05-15

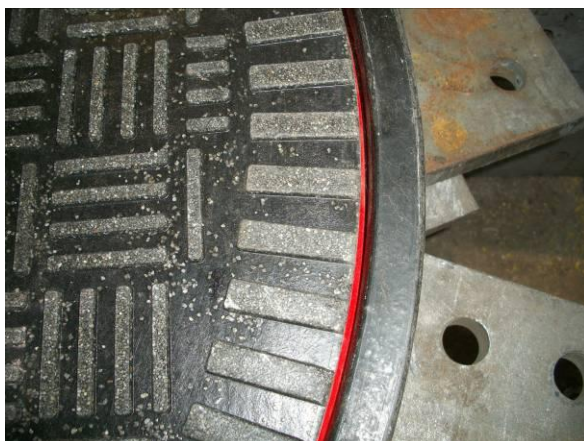
Photo.3

Below photograph 3 shows the gap that appeared between the edge of the cover and frame by the two thirds test load of 267kN.

The gap was about 5mm at either side whilst photograph 4 shows no gap, this was at the front and back edge as you look at the test rig.

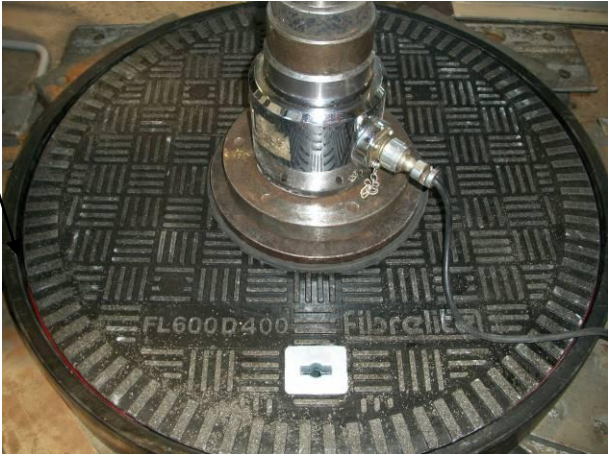
Photo.5

Photograph 5 now shows the cover and frame at the failure load of 421kN.

10mm gap and cover sunk in
15mm from top edge of frame

No gap

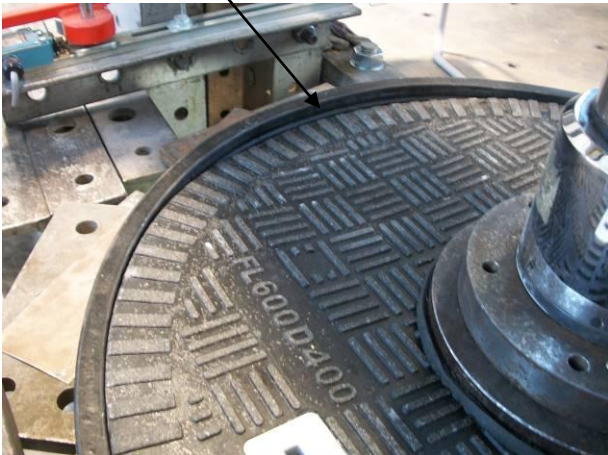
Photo.6

Photograph 6 shows a close up of the depressed cover.

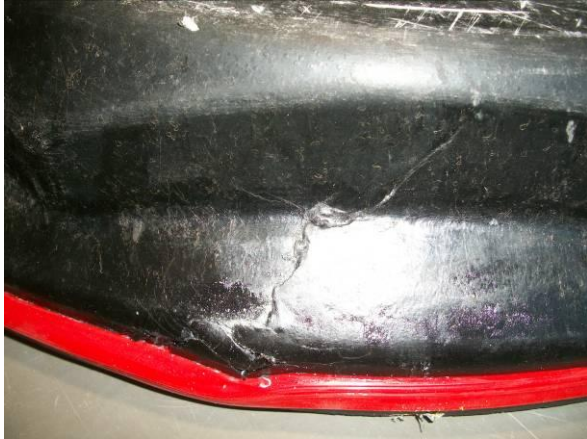
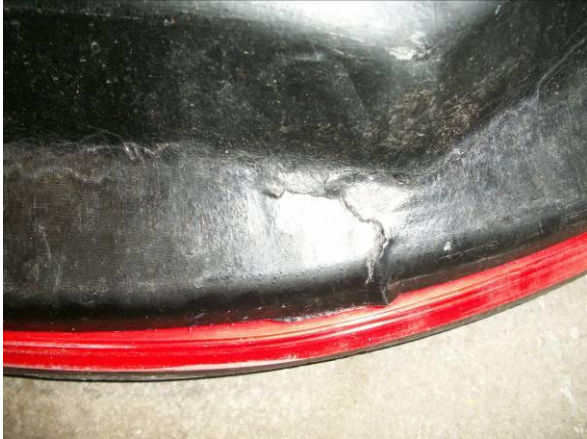
The cover had a number of large cracks down the outside edge. (Photos.7 and 8)

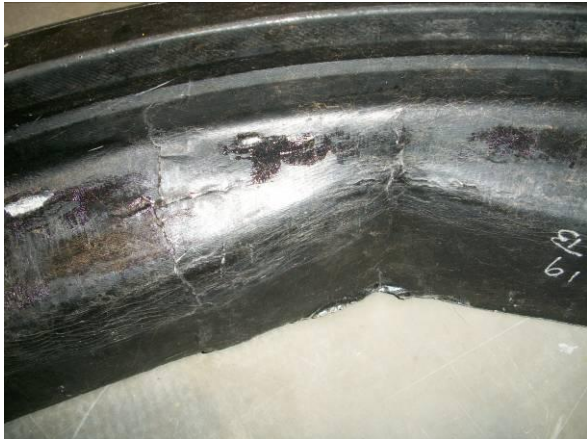
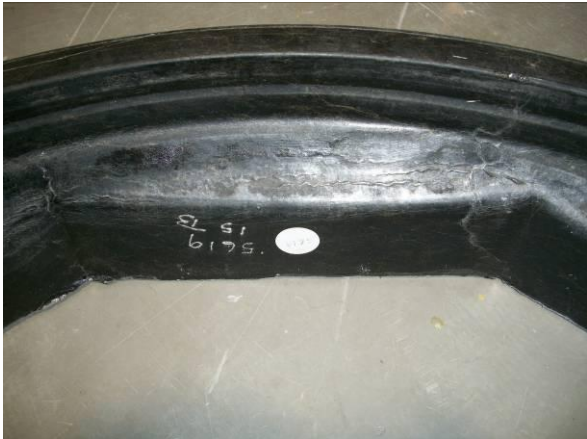
The frame also showed some damage with cracks on its inside edge and face. (Photos.9 and 10)
