## **TEST REPORT**

### **FL760 Cover Test to EN124 C250**

Date: 19/06/09

**Client: Fibrelite Composites Ltd.**

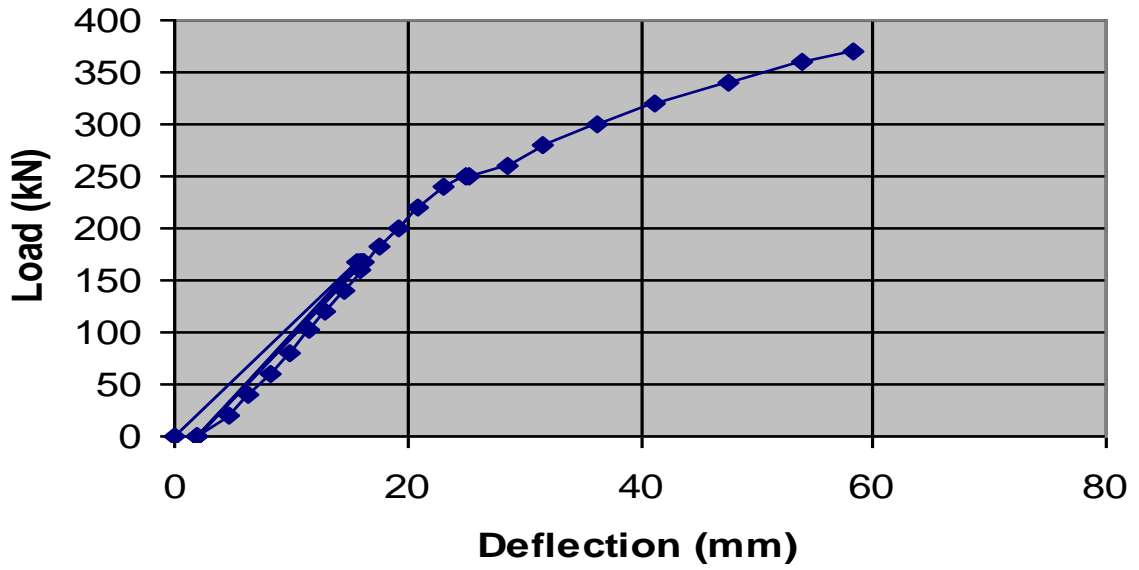
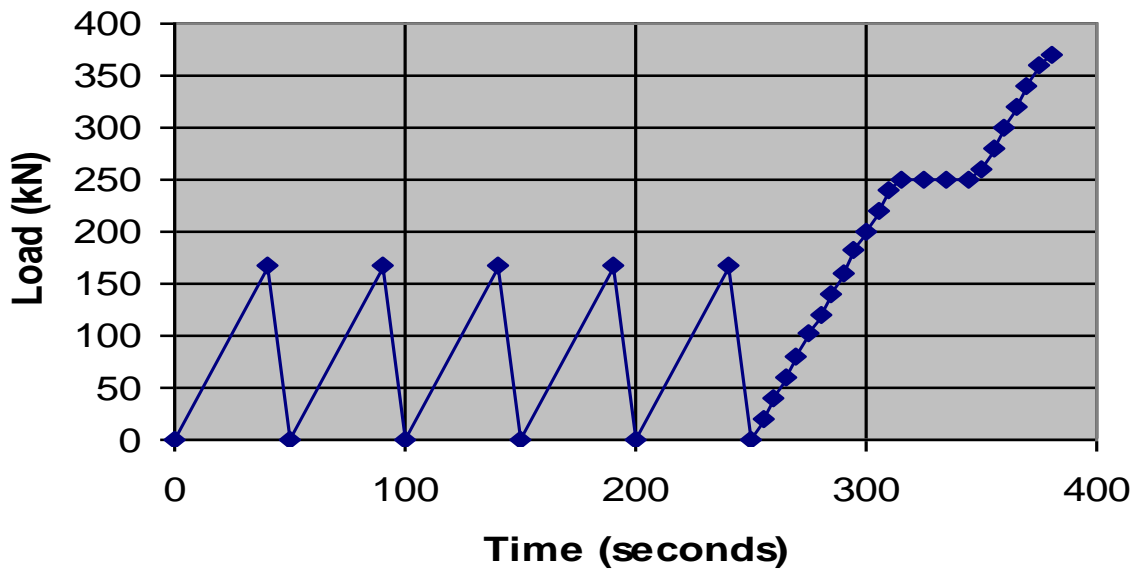
### FL760 EN124 Class C250

**In accordance with EN124 Clause 8.3.1 the permanent set of the cover was 1.93mm which is within the permissible stated in Table 8 of the standard. (1/300 x 760 = 2.53mm).**

**The cover held the test load of 250kN for the required 30 seconds and therefore passed the EN124 C250 test.**

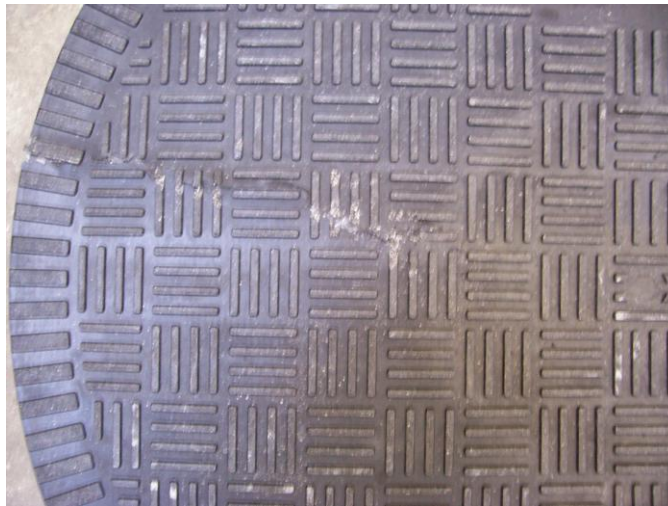
Photo.3

By 360kN there were lots of loud cracking and the cover finally failed at 369kN with a loud bang.

On the top surface the cover was permanently deformed in the area of the loading pad and a large crack ran through the centre of the cover and down the edge. (See photos 3 & 4)

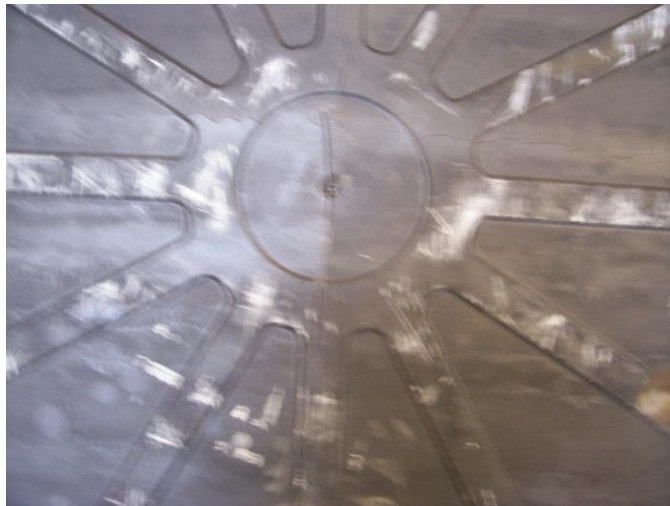
Photo.5

On the underside there were two large cracks running right across the cover and at right angles to each other. (See photo.5)
