TEST REPORT

FL90 B125 Cover Test

Date: 14/04/11

Client: Fibrelite Composites Ltd.

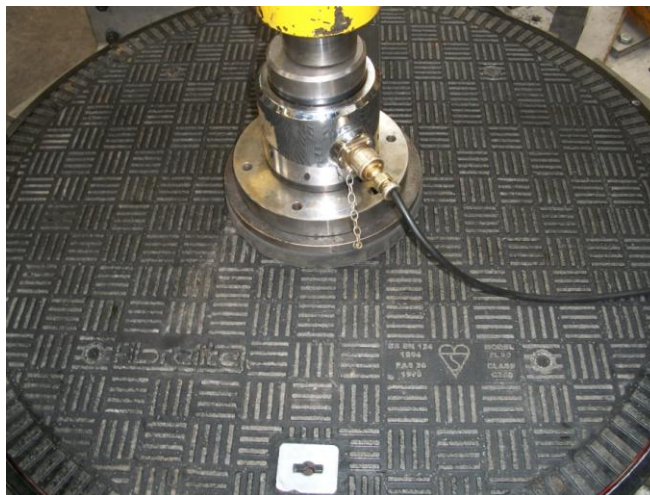
Photo. 1

The cover supplied is a round FL90 and of composite construction. (See photo. 1)
No. on cover – no number

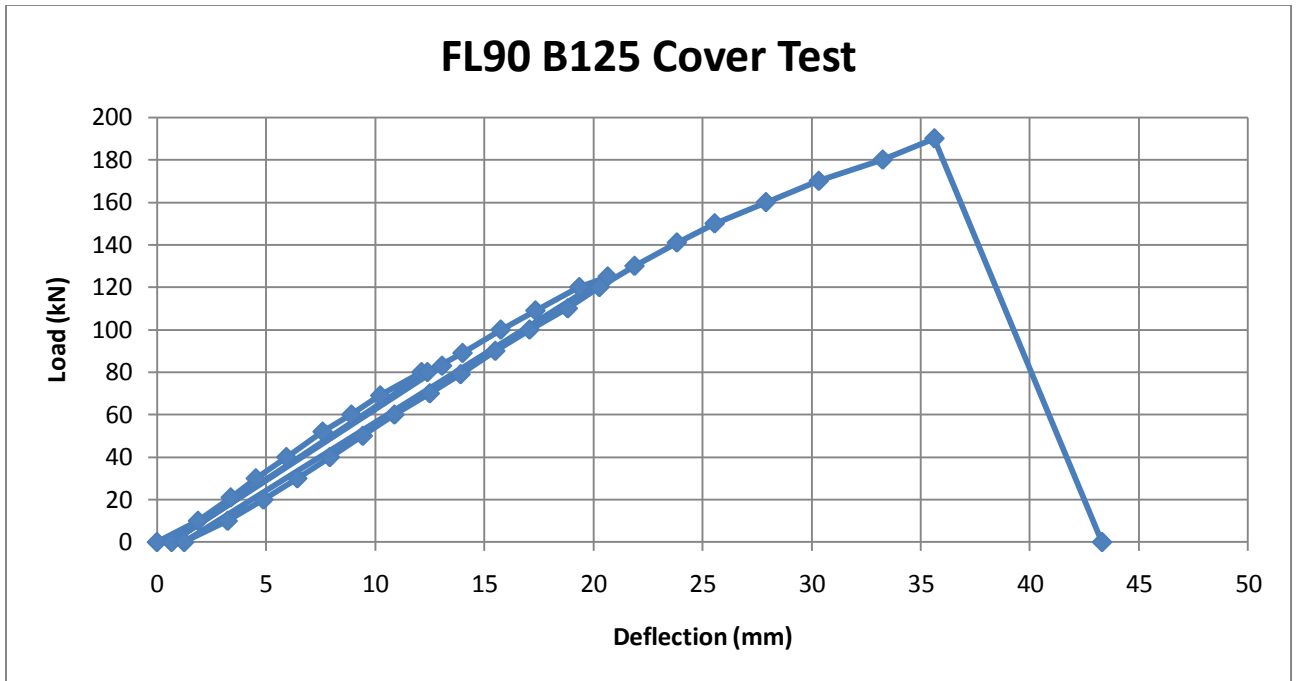
The permanent set at 83kN (2/3 test load) was 0.67mm.

The permanent set at 125kN (test load) was 1.25mm.

The cover failed at 190kN.

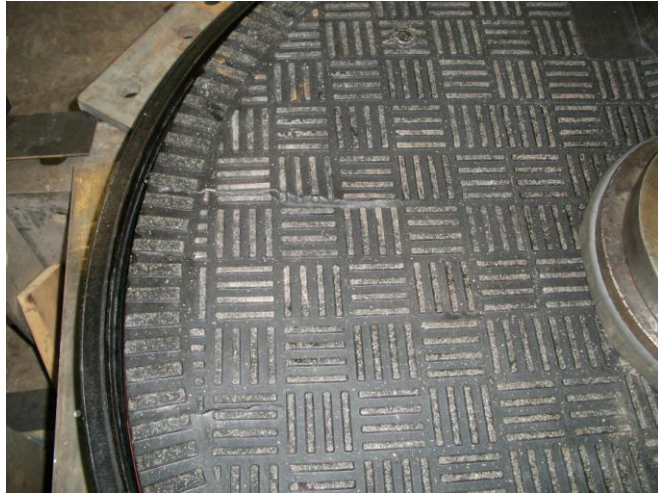
Photo.3

Photograph 3 shows the cover still in the test rig under load at failure and a large crack running across the cover.

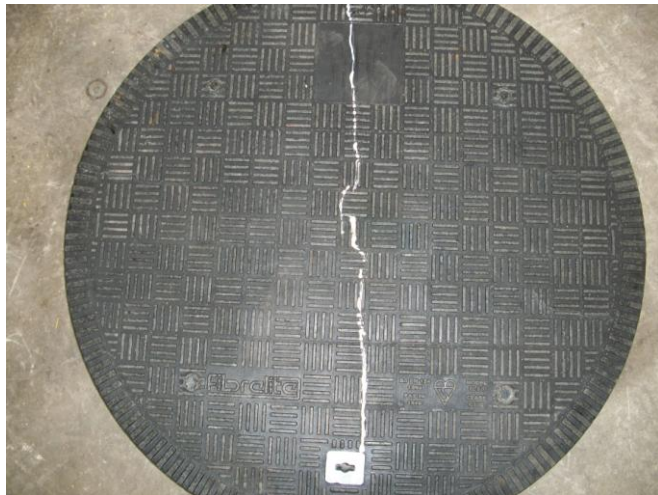
Photo.4

Photograph 4 shows the cover out of the test rig and the full extent of the crack running across the cover and coloured in white to show up.

There were no signs of any damage to the frame.
