TEST REPORT

FM45 EN124 D400 Test

Date: 02/11/11

Client: Fibrelite Composites Ltd.

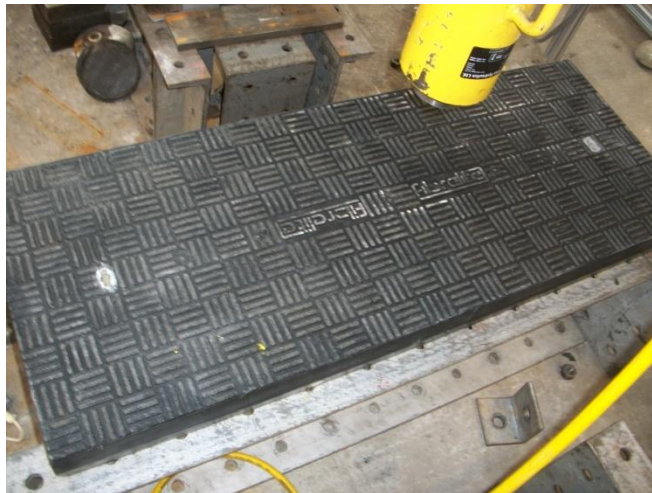
Photo. 1

The cover supplied is a rectangular FM45 and of composite construction. (See photo. 1)

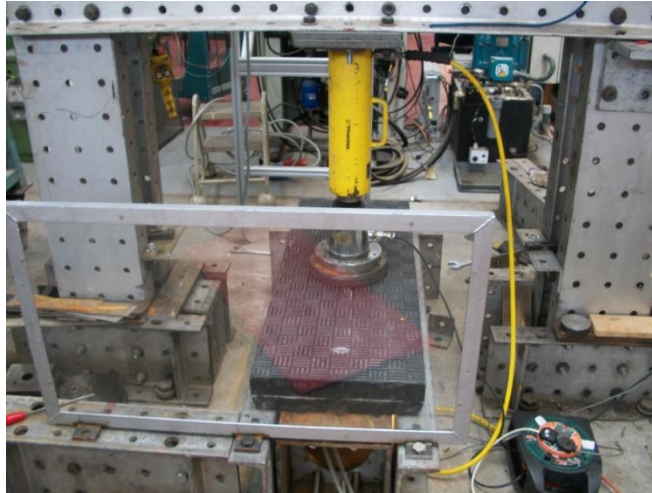
Photo. 2

The test rig consists of a 'giant mecano' frame bolted to the floor and supporting the Enerpac 50 tonne hydraulic cylinder. (Photo 2)

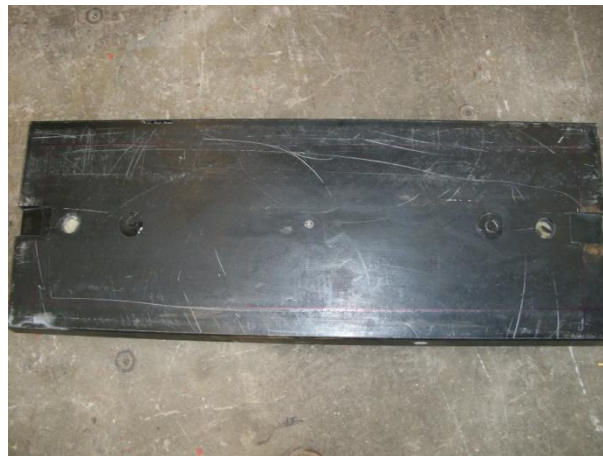
Photo.3

The cover finally failed at 438kN with a number of cracking and banging noises and the cover unable to take any more load.

Photograph 3 shows the underside of the cover after it had been removed from the test rig. There were no signs of any cracking.
