## **TEST REPORT**

### **FM45 EN124 A15 Test**

Date: 27/04/12

**Client: Fibrelite Composites Ltd.**

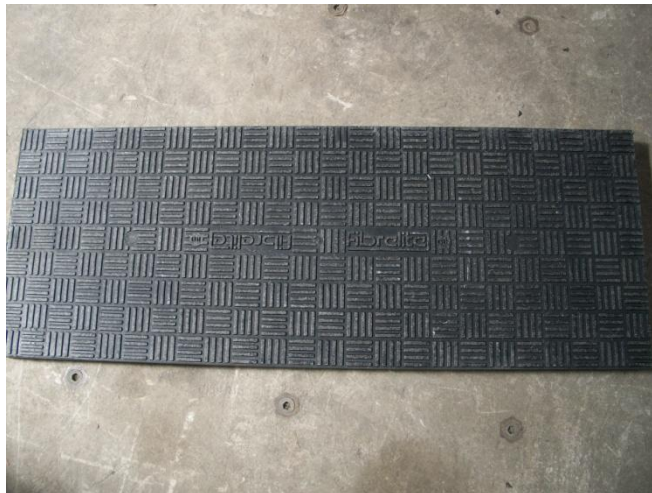
Photo. 1

The cover supplied is a rectangular FM45, 1200mm x 450mm and of composite construction.  
(See photo. 1)

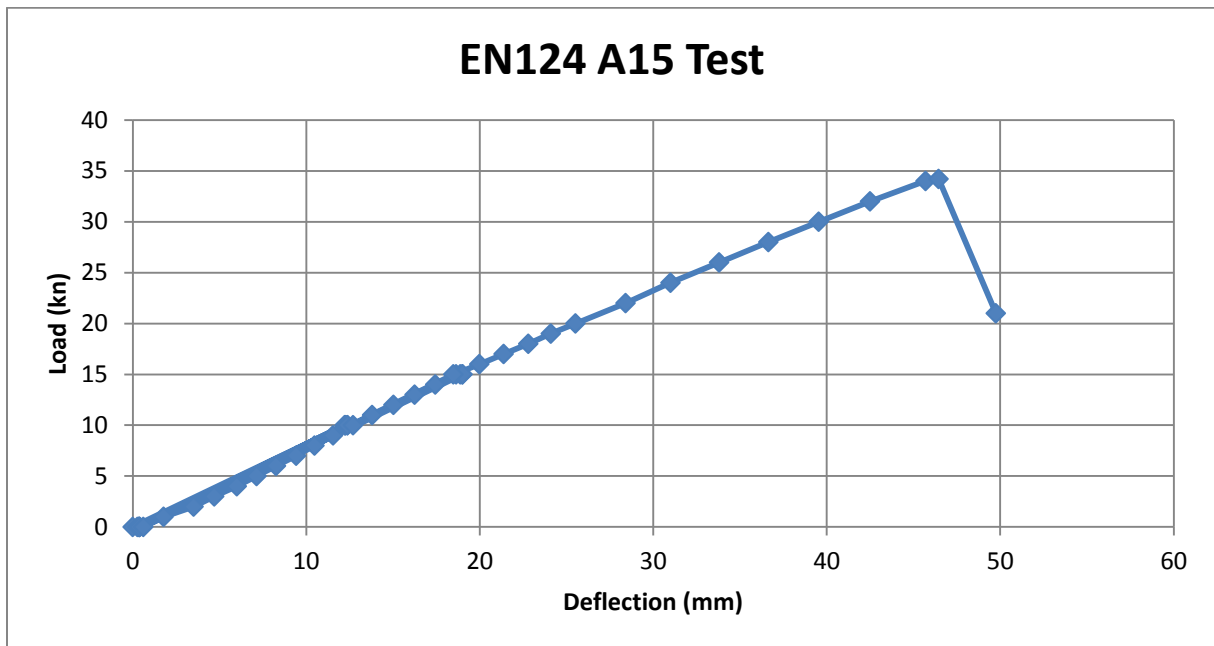
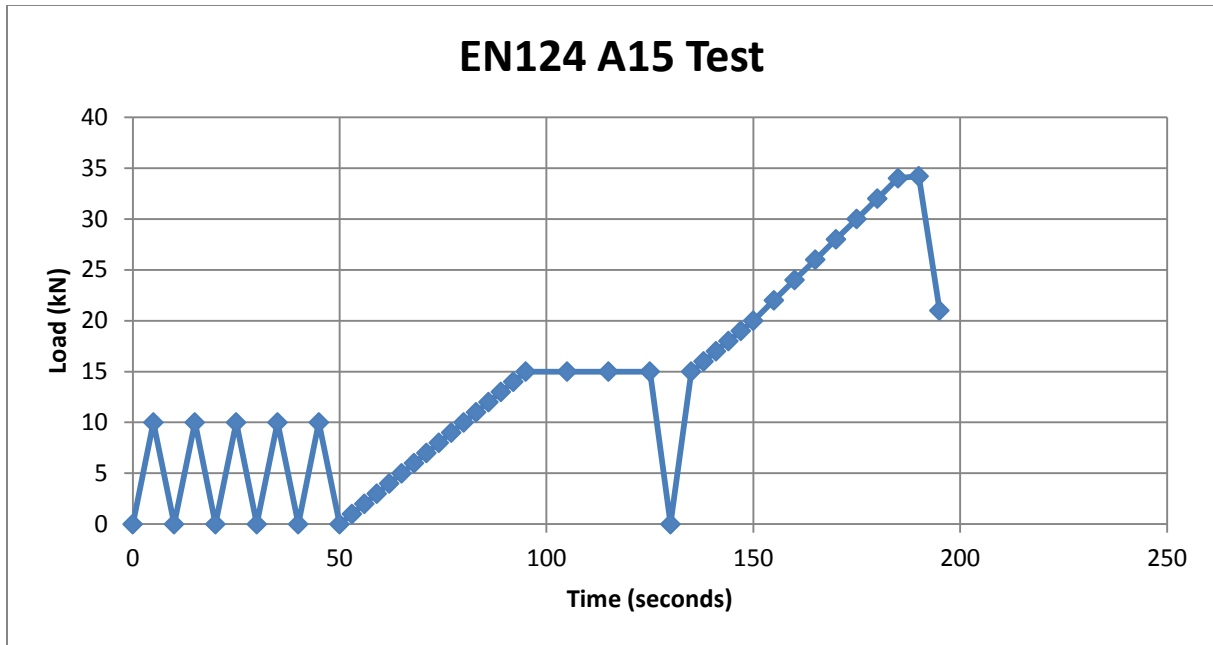
**In accordance with EN124 Clause 8.3.1 the permanent set of the cover was 0.39mm which is within the permissible stated in Table 8 of the standard. ( $1/100 \times 450 = 4.50\text{mm}$ ).**

**The cover reached the test load of 15kN and held for the required 30 seconds.**

**The cover therefore passed the EN124 A15 test for both permanent set and load.**

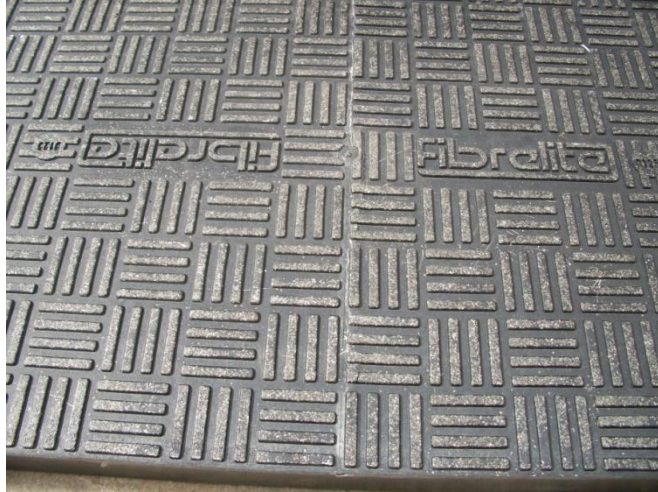
Photo.3

The panel was then loaded up to achieve failure which occurred at 34.2kN

Photograph 3 shows the panel after failure with a large crack running right across the center of the cover.
