TEST REPORT

FM45-B125SH-120 Trench Panel EN124 B125 Test

Date: 29/04/13

Client: Fibrelite Composites Ltd.

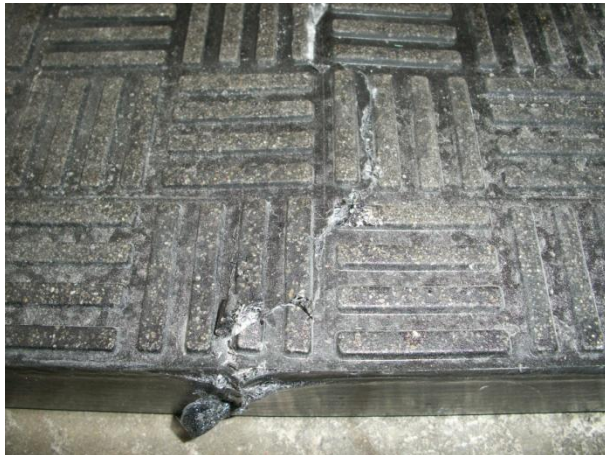
Photo.4

The panel was then loaded again to achieve failure which occurred at 150kN.

Photographs 3 and 4 show a large crack on the top face of the panel at failure.
