TEST REPORT

FM65-160/50/LD Trench Panel EN124 B125 Test

Date: 17/07/14

Client: Fibrelite Composites Ltd.

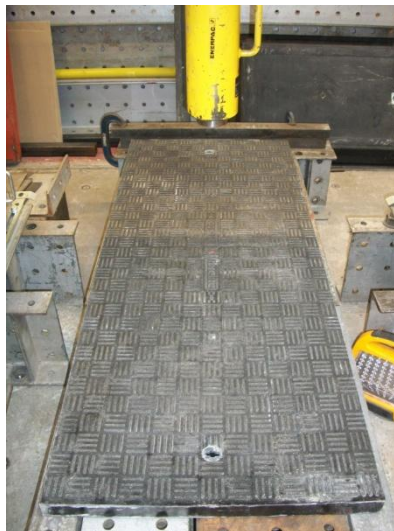
Photo. 1

The panel supplied is a rectangular FM65, 1600mm x 650mm x 50mm and of composite construction. (See photo. 1)

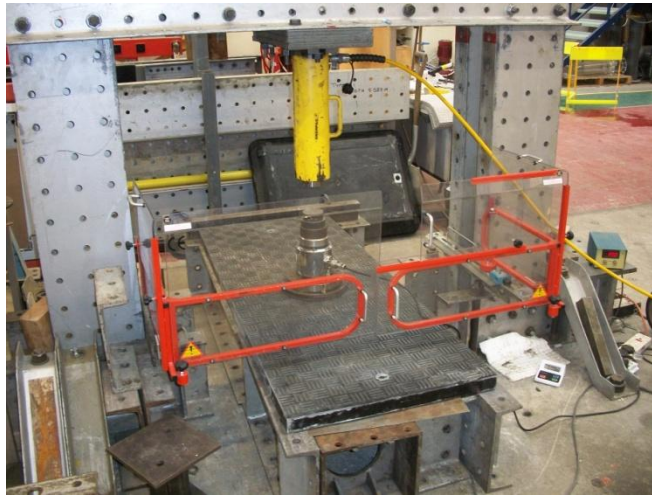
Photo. 2

The test rig consists of a 'giant mecano' frame bolted to the floor and supporting the Enerpac 50 tonne hydraulic cylinder. (Photo 2)

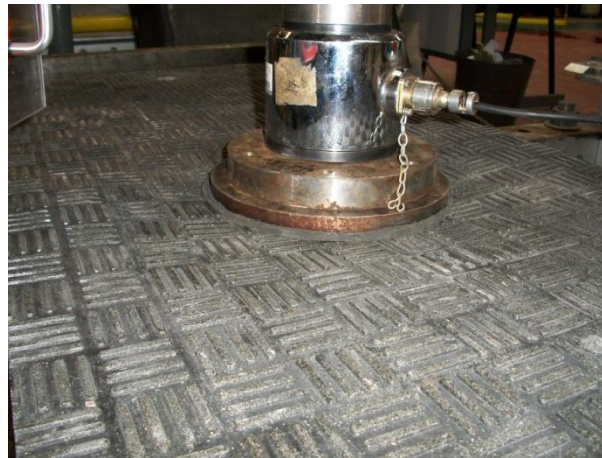
Photo.3

The panel was then loaded again until failure which occurred at 208kN.

Photograph 3 shows the panel in the test rig at failure.

There were no visible cracks at failure but there was a permanent depression in the panel in the area of the loading pad.
