TEST REPORT

FL140 Composite Cover BS EN124 C250 Test

Document reference number - FIB-FL140-21-06-16

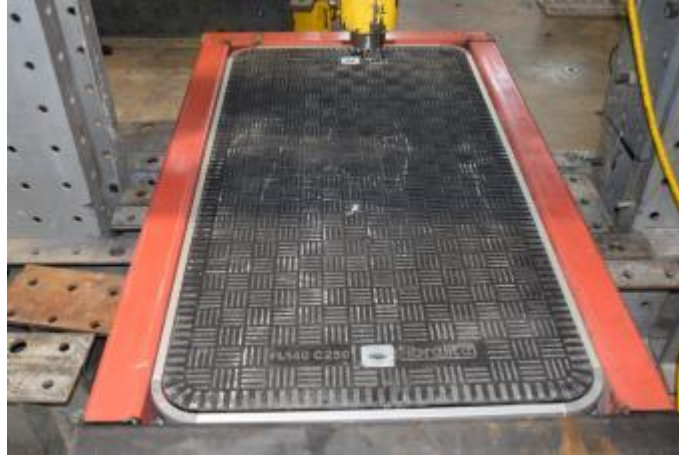
Photo. 1

The composite cover supplied for load testing is a rectangular FL140 complete with frame.
(Photo.1)

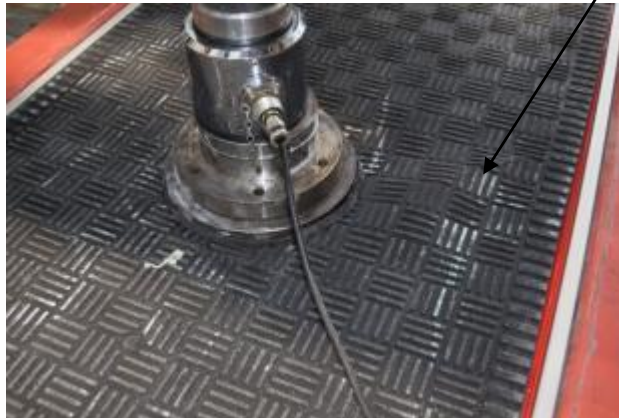
Photo.3

Photograph 3 shows the cover still in the test rig at failure. (Crack)

After the cover had passed the C250 load test the load was removed and the cover inspected. The dial gauge was removed to avoid damage and the cover then reloaded until failure occurred at 305kN.

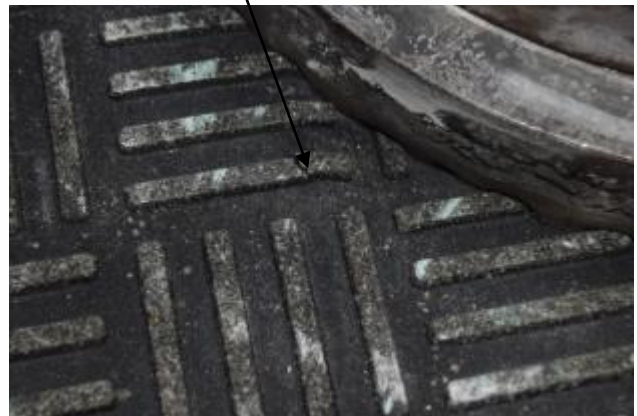
The following two photographs show the cracking and damage that occurred to the top face of the cover at the failure load of 305kN.

Buckled up

Crack

Cracking round edge of loading pad
