TEST REPORT

FL180 Composite Cover BS EN124 Class D400 Load Test

Document reference number – FIB-FL180-D400-13-02-24

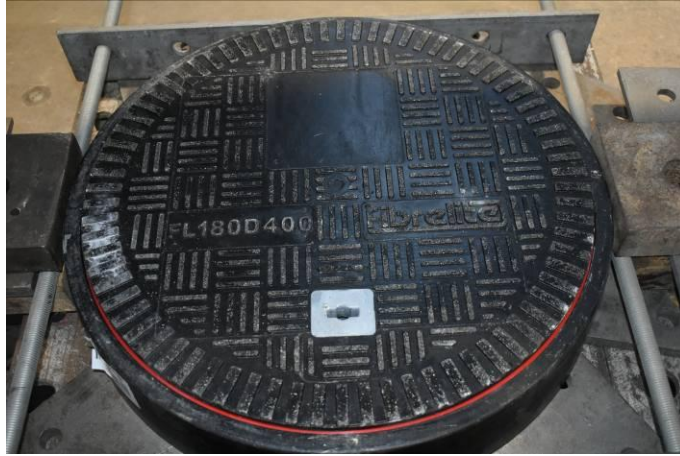
Photo. 1

A round FL180 composite cover and frame have been supplied for load testing (Photo.1)

Cover No. 2400645

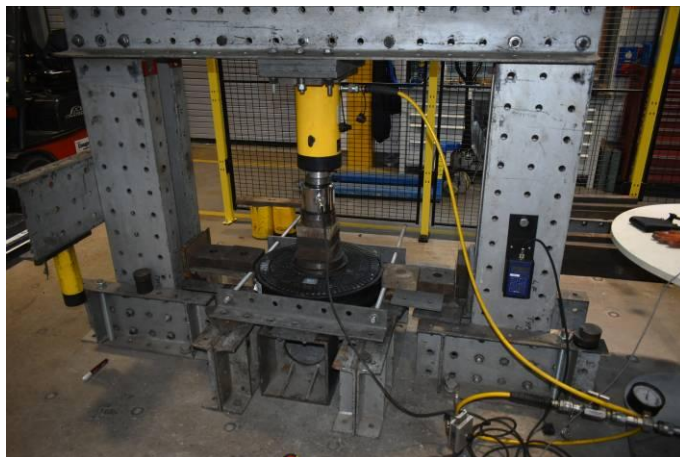
Photo.2

The test rig consists of a 'giant mecano' frame bolted to the floor and supporting an Enerpac 90 ton hydraulic cylinder. (Photo.2)

A steel structure was fitted in place to support the frame for both stability and safety.

In accordance with the EN124-1:2015 standard the load cell and test rig complies with EN ISO 7500-1:2004 minimum Class 3.

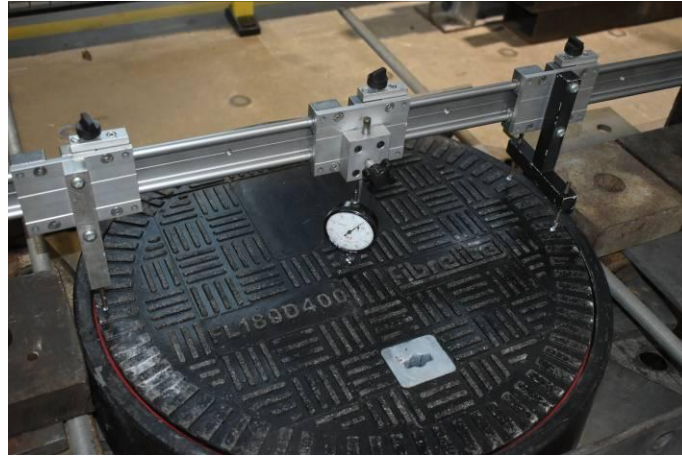
Photo.4

Initial Reading	0.00mm
Reading after 5 cycles	0.37mm
Permanent Set	0.37mm

Permissible permanent set for a D400 test is $\frac{CO}{300} = 450/300 = 1.50\text{mm}$

Therefore panel passes the permanent set test.

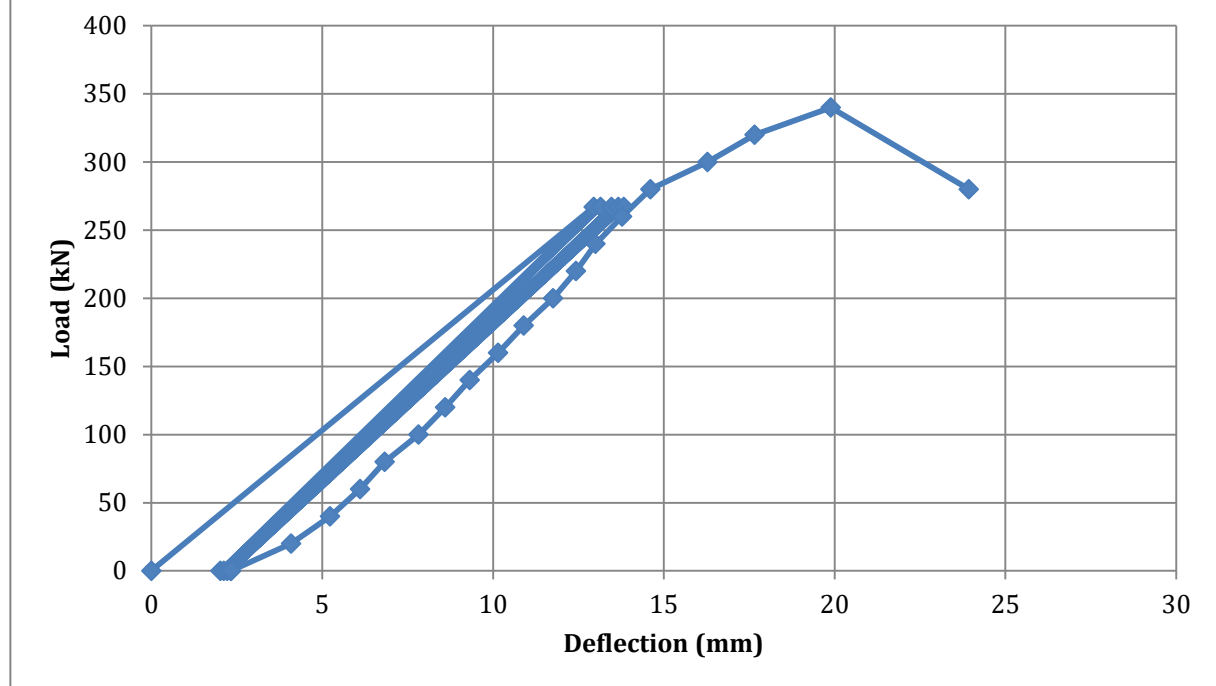
FL180 Composite Cover BS EN124 Class D400 Load Bearing Test

LOAD (kN)	DEFLECTION (mm)	REMARKS
0	0.00	
267	12.95	
0	2.02	
267	13.15	
0	2.12	
267	13.47	
0	2.22	
267	13.67	
0	2.33	
267	13.83	
0	2.33	
20	4.09	
40	5.23	
60	6.11	
80	6.83	
100	7.82	
120	8.60	
140	9.32	
160	10.15	
180	10.90	
200	11.76	
220	12.43	
240	13.00	
260	13.78	
280	14.61	
300	16.28	
320	17.66	
340	19.89	FAILURE – loud cracking and load dropping off.
280	23.93

The cover failed at 340kN and did not reach the required test load of 400kN, so therefore the cover failed the BS EN124 Class D400 load bearing test.

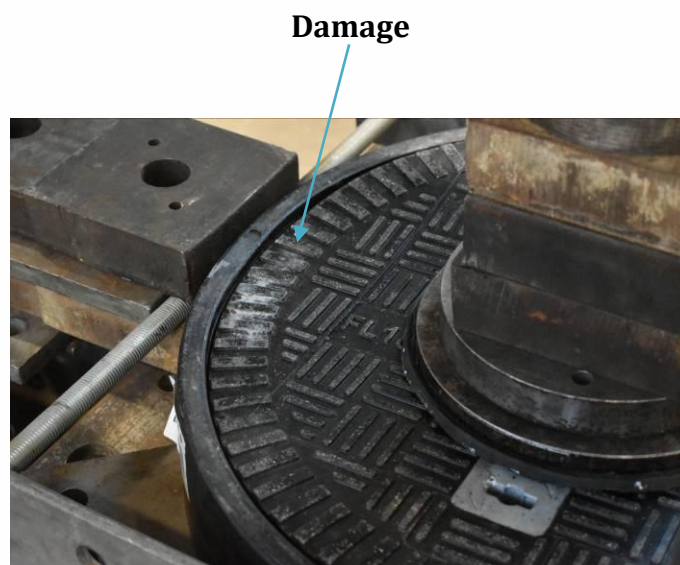
Photo.5

Photograph 5 below shows the cover still in the test rig at failure, with the top of the cover deformed and pushing down into the frame.

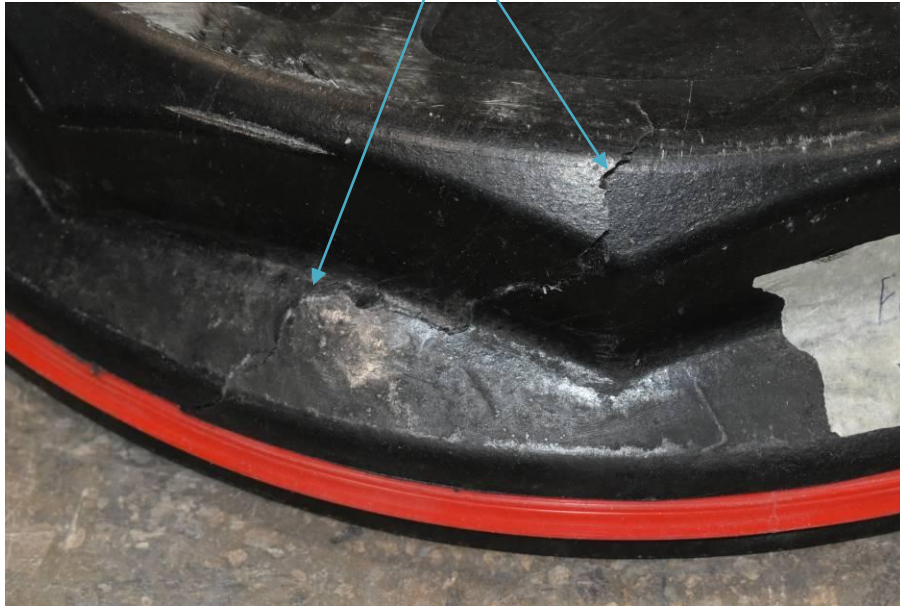
Photo.6

Photograph 6 shows major cracking to the underside and down one edge of the cover

Major failure

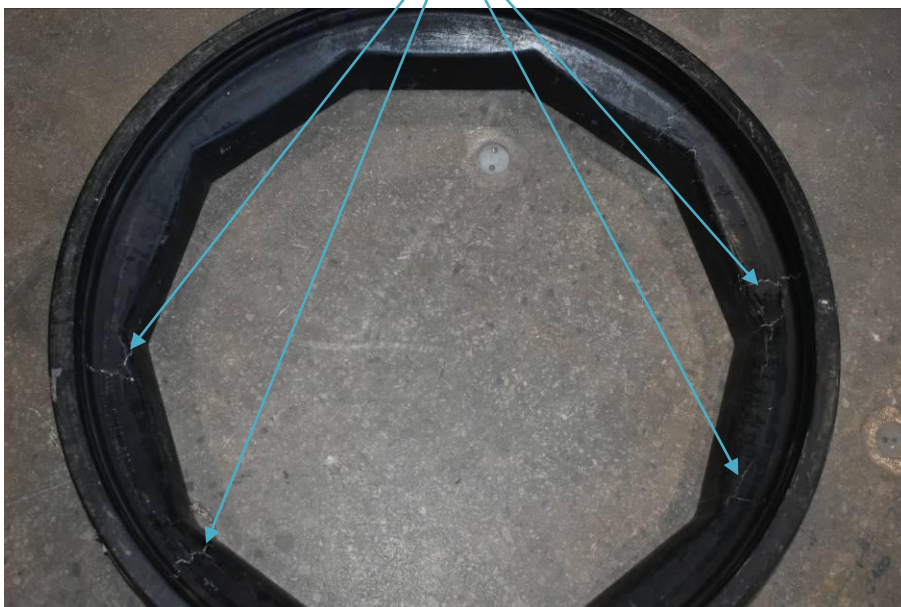
Photo.7

There was also significant damage to the inside of the frame.

Cracking
