TEST REPORT

FL450 Composite Cover BS EN124 B125 Test

Document reference number - FIB-FL450-B125-21-12-16

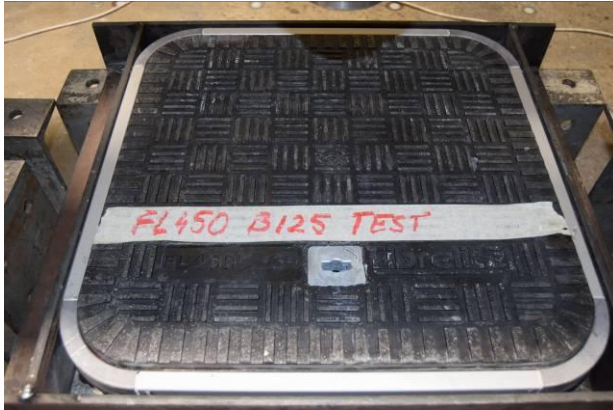
Photo. 1

The composite cover supplied is a square FL450 complete with aluminium frame. (Photo.1)

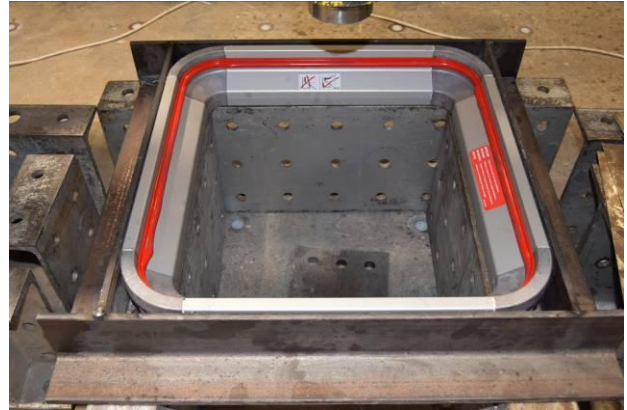
Photo.2

The test rig consists of a 'giant mecano' frame bolted to the floor and supporting the Enerpac 50 ton hydraulic cylinder.

The cover was seated on steel channels with steel shims to pack and level.

A steel frame made from 100mm x 75mm x 10mm steel angle was placed round the frame to act as a support. (Photo.2)

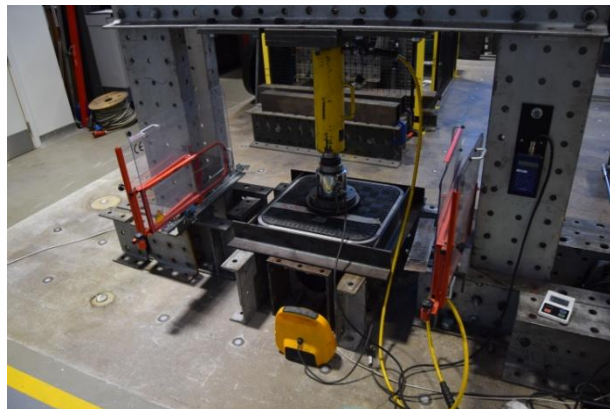
Photo.3

The load was applied to the cover through a 250mm diameter by 45mm thick steel block with a 250mm diameter by 10mm rubber pad between the block and cover.

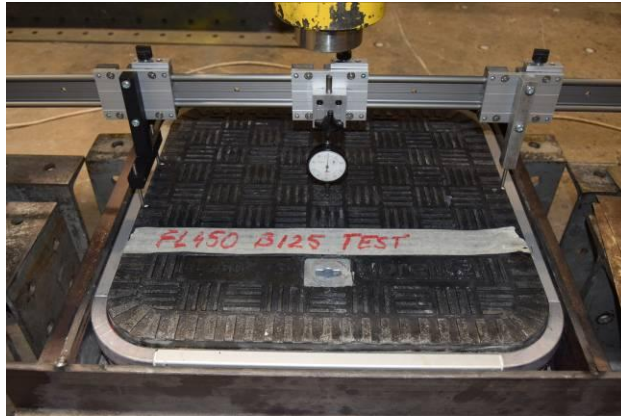
Photo.4

Photograph 4 below shows the initial reading being taken for the permanent set test.

Initial Reading	0.00mm
Reading after 5 cycles	0.20mm
Permanent Set	0.20mm

Permissible permanent set for a B125 test is $\frac{CO}{100} = 450/100 = 4.50\text{mm}$

Therefore cover passes the permanent set test.

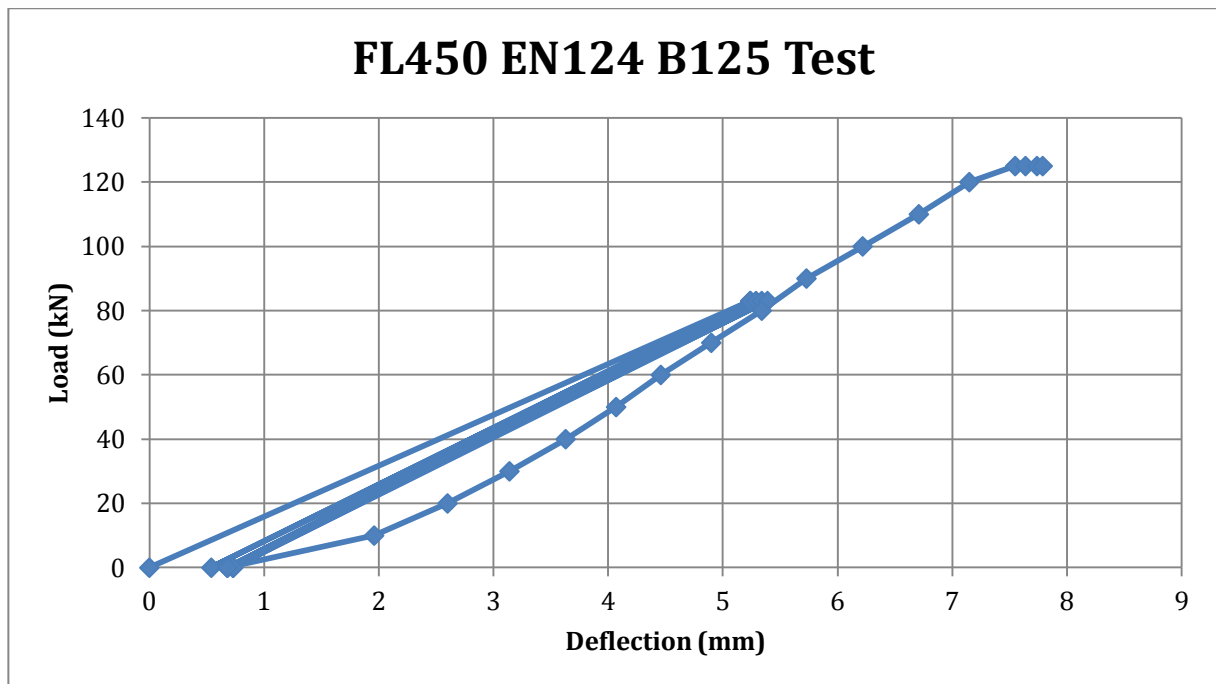
LOAD (kN)	DEFLECTION (mm)	REMARKS
0	0.00	
83	5.24	
0	0.54	
83	5.24	
0	0.68	
83	5.29	
0	0.73	
83	5.34	
0	0.73	
83	5.39	
0	0.68	
10	1.96	
20	2.60	
30	3.14	
40	3.63	
50	4.07	
60	4.46	
70	4.90	
80	5.34	
90	5.73	
100	6.22	
110	6.71	
120	7.15	
125	7.55	
125	7.64	
125	7.74	
125	7.79	PASS
0	1.12	
172	Gauge removed	Loud cracking and banging noises.
188	-	Ultimate failure

The cover held the test load of 125kN for the required 30 seconds so therefore passed the load bearing test.

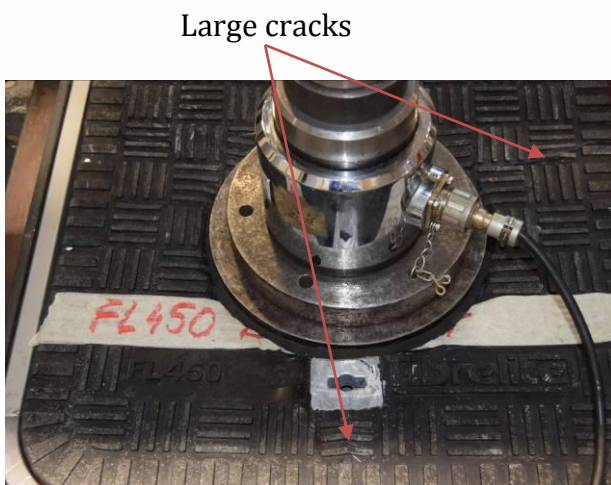
Photo.5

The cover was then loaded further until ultimate failure occurred at 188kN.

Photograph 5 below shows the cover still in the test rig at failure and the top face badly deformed around the loading pad area with a number of large cracks.
