TEST REPORT

FL60 Composite Cover BS EN124 D400 Test

Document reference number - FIB-FL60-D400-15-12-17

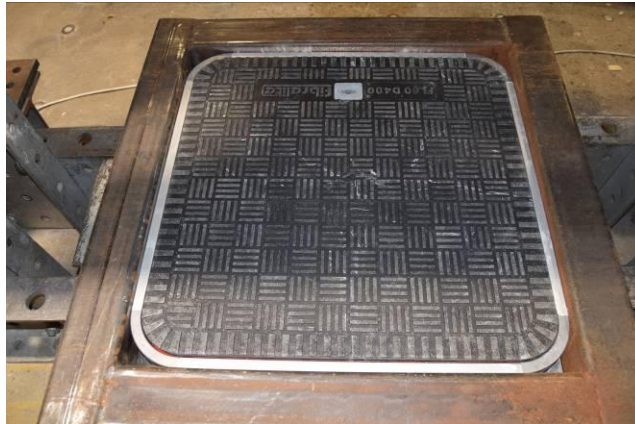
Photo. 1

The composite cover supplied is a square FL60 complete with aluminium frame. (Photo.1)

A steel frame made from 100mm x 100mm steel box section was placed round the frame to act as a support. (Photo.1)

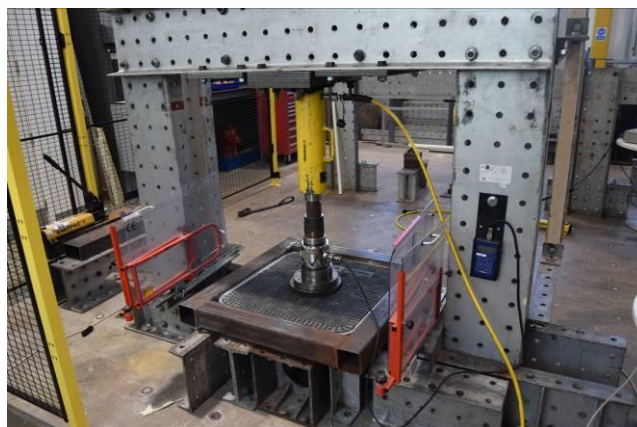
Photo.2

The test rig consists of a 'giant mecano' frame bolted to the floor and supporting the Enerpac 50 ton hydraulic cylinder.

The cover was seated on steel channels with steel shims to pack and level.

In accordance with the EN124-1:2015 standard the load cell and test rig complies with EN ISO 7500-1:2004 minimum Class 3.
