# TEST REPORT

## FL76 Composite Cover BS EN124 B125 Test

Document reference number - FIB-FL76-B125-13-11-17

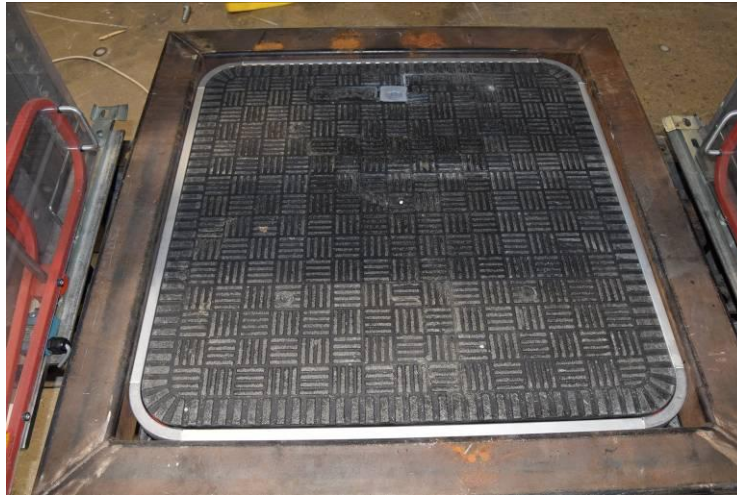
Photo. 1

The composite cover supplied is a square FL76 complete with aluminium frame.  
(Photo.1)

A 100mm x 100mm steel box section frame was placed around the aluminium frame to add support and as an added safety feature incase of failure.

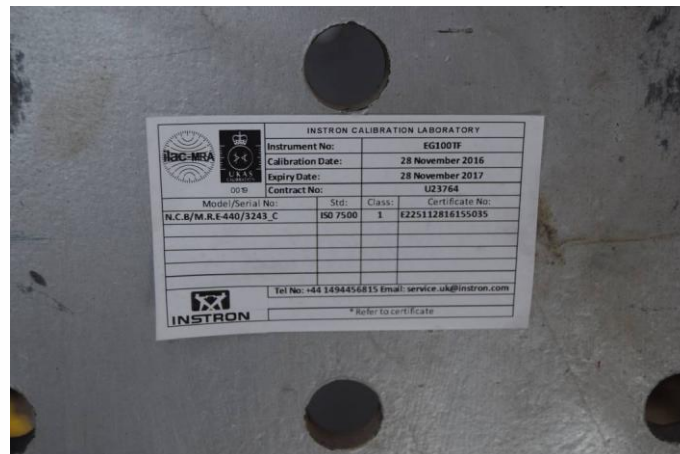
Photo.3

Calibration sticker (Photo.3)
