# TEST REPORT

## FL900 Composite Cover BS EN124 A15 Test

Document reference number - FIB-FL900-A15-20-12-16

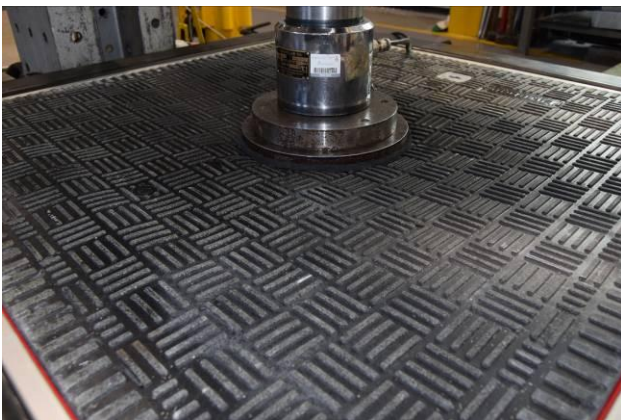
Photo.4

Photograph 4 below shows the cover still in the test rig at failure and the top face badly deformed around the loading pad area.

A larger capacity 1000kN load cell (SN. 3243N) replaced the 50kN one and the cover loaded further until ultimate failure occurred at 117.8kN.

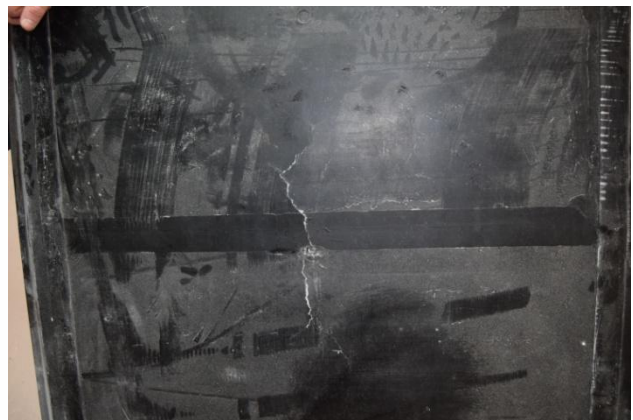
Photo.5

On removal from the test rig the underside had a large crack running through the centre of the cover. (Photo.5)
