TEST REPORT

FL100 Cover Test

Client: Fibrelite Composites Ltd.

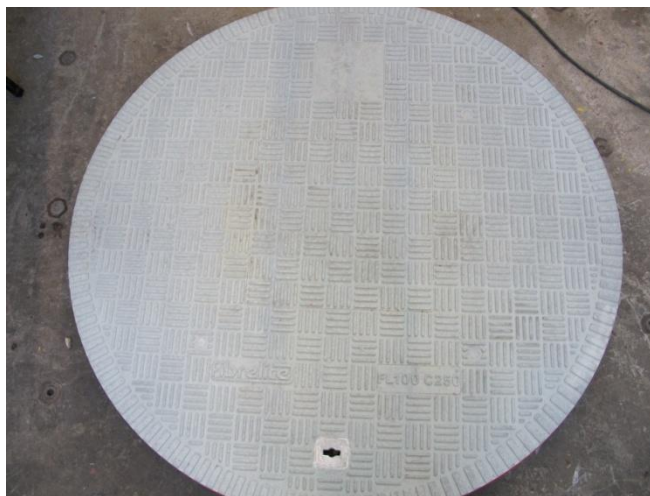
Photo. 1

The cover supplied is a round FL100 and of composite construction. (See photo. 1)
Cover No. - no number.

The cover was tested in a composite frame.
Frame No. – no number.

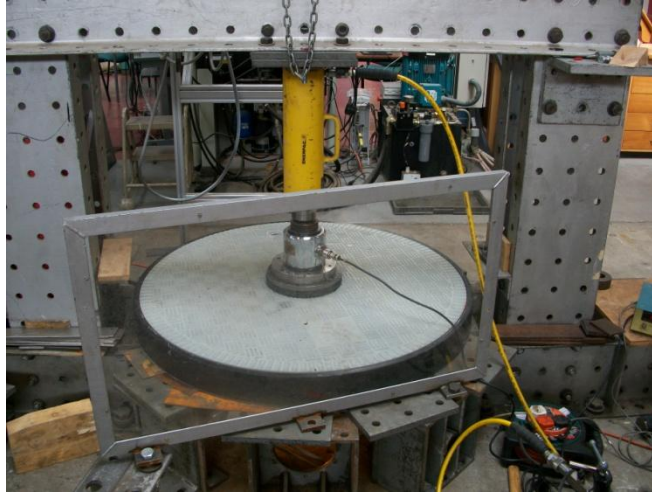
Photo. 2

The test rig consists of a 'giant mecano' frame bolted to the floor and supporting the Enerpac 50 tonne hydraulic cylinder. (Photo 2)

The cover and frame were sat on steel channels and plates with steel shims to pack and level.

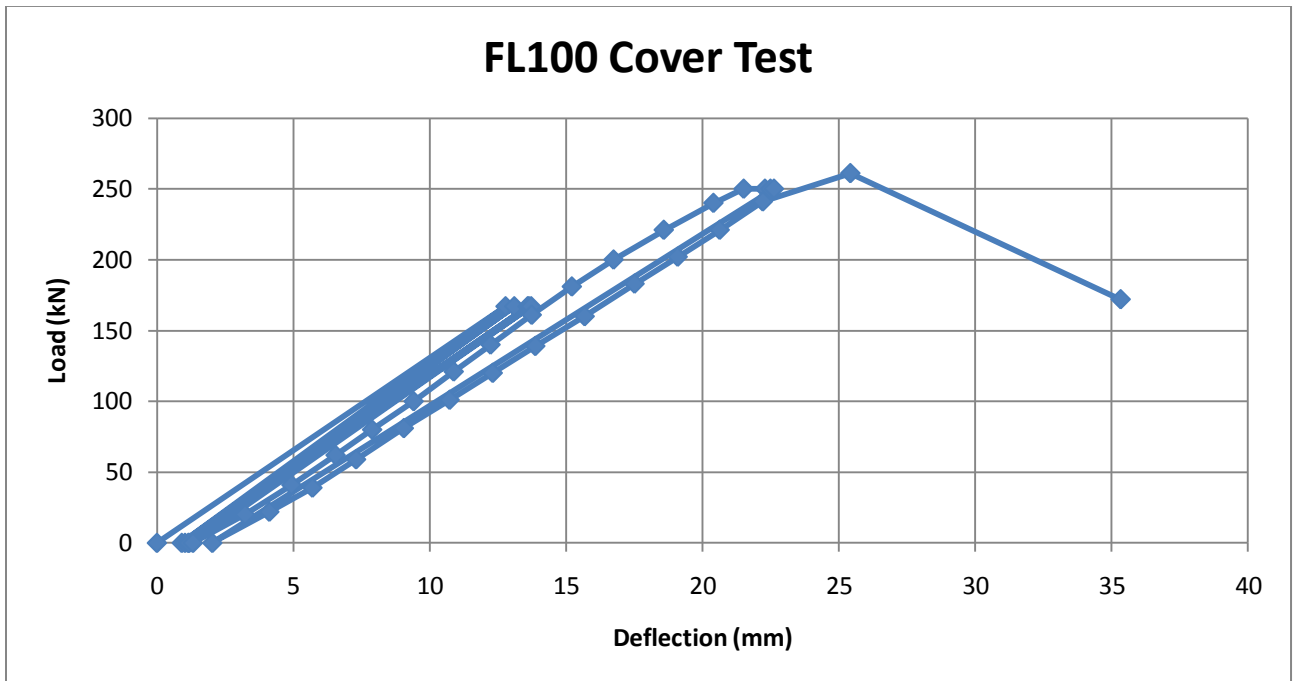
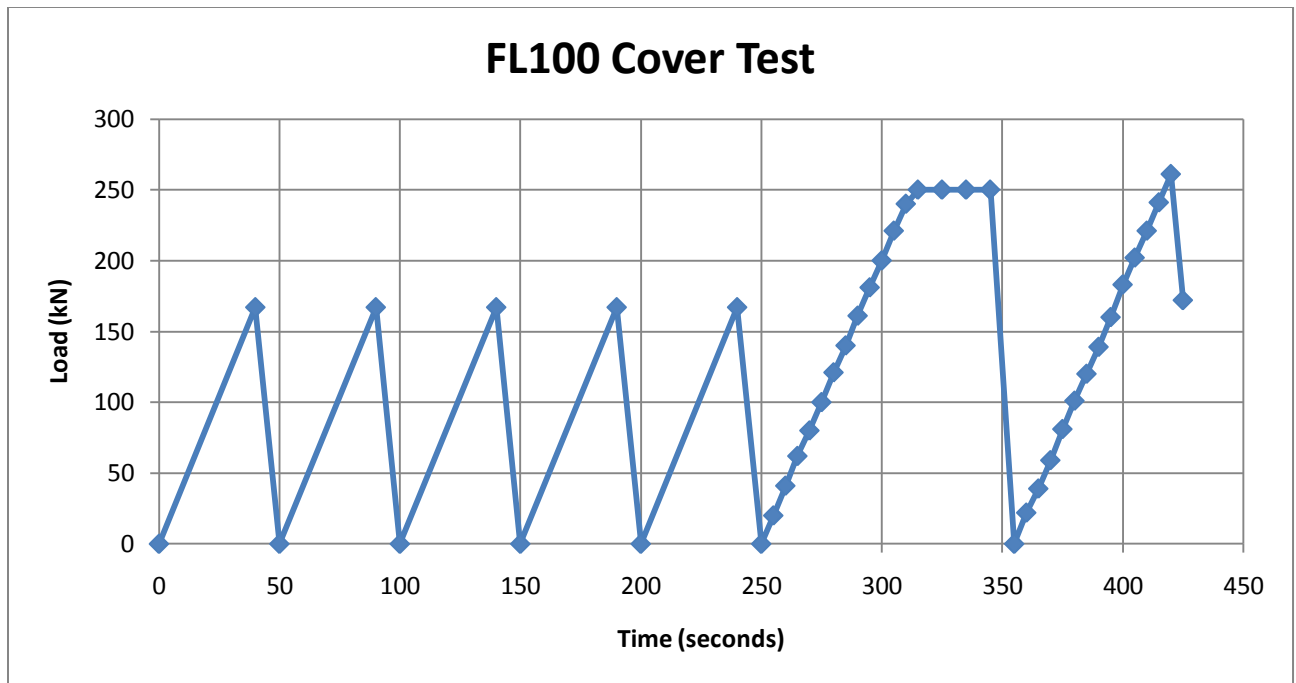
Load (kN)	Deflection (mm)	Remarks
0	0.00	
167	12.78	Light cracking noises from 30kN onwards for the 1 st cycle.
0	0.91	
167	13.10	
0	1.03	
167	13.59	
0	1.15	
167	13.64	
0	1.18	
167	13.72	
0	1.32	
20	3.23	
41	4.93	
62	6.55	
80	7.89	
100	9.41	
121	10.88	
140	12.23	
161	13.74	
181	15.21	
200	16.74	
221	18.58	Louder cracking noises
240	20.40	
250	21.51	
250 (10 seconds)	22.29	
250 (20 seconds)	22.49	
250 (30 seconds)	22.62	
0	2.03	
22	4.12	
39	5.70	
59	7.30	
81	9.05

101	10.73	
120	12.31	
139	13.87	
160	15.68	
183	17.51	
202	19.09	
221	20.63	
241	22.21	
261	25.42	Loud cracking / tearing noises – failure.
172	35.33

The cover held the test load of 250kN for the required 30 seconds so therefore passed the EN124 C250 test.

In accordance with EN124 Clause 8.3.1 the permanent set of the cover was 1.32mm which is within the permissible stated in Table 8 of the standard. ($1/300 \times 1000 = 3.33\text{mm}$).

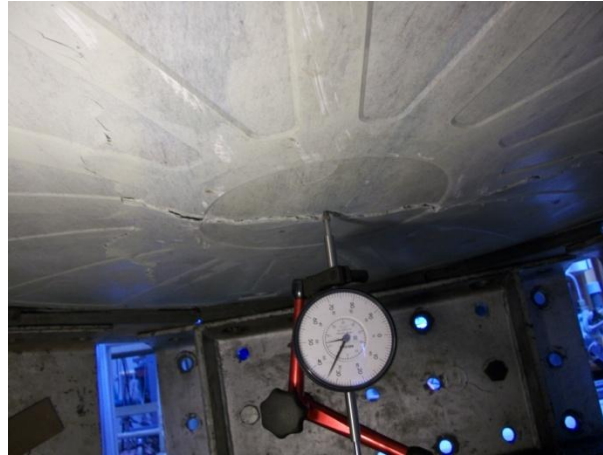
Photo.4

Photograph 4 shows the cover still in the test rig under load at failure and a large crack running across the cover through the centre.

The cover was then loaded again until failure at 261kN

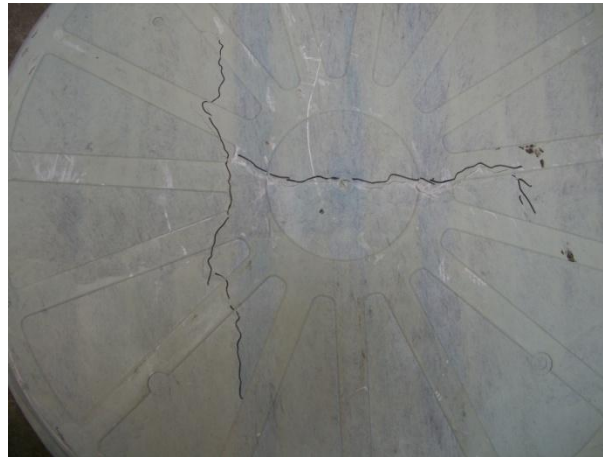
Photo.5

Photograph 5 shows the cracking on the underside after the cover has been removed from the test rig.

There were no signs of any cracking to the top surface of the cover or any damage to the frame.
