# TEST REPORT

## 700 x 448 x 76 Composite Trench Panel BS EN124 C250 Test

Document reference number - FIB-700-448-76-30-07-15

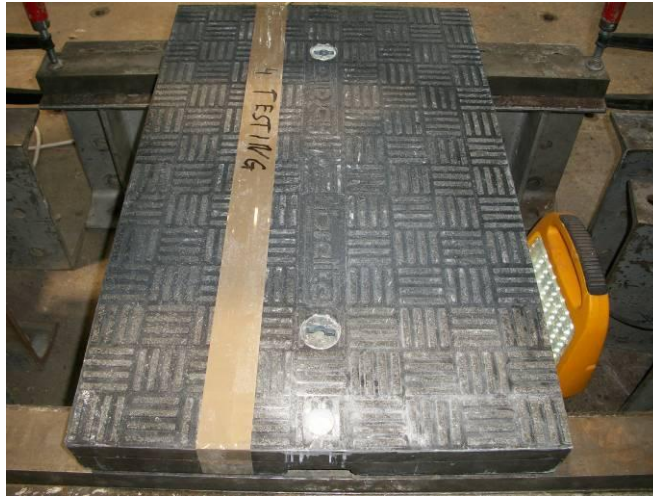
Photo. 1

The panel supplied for testing is a 700mm long x 448mm wide x 76mm deep composite trench panel. (Photo.1)

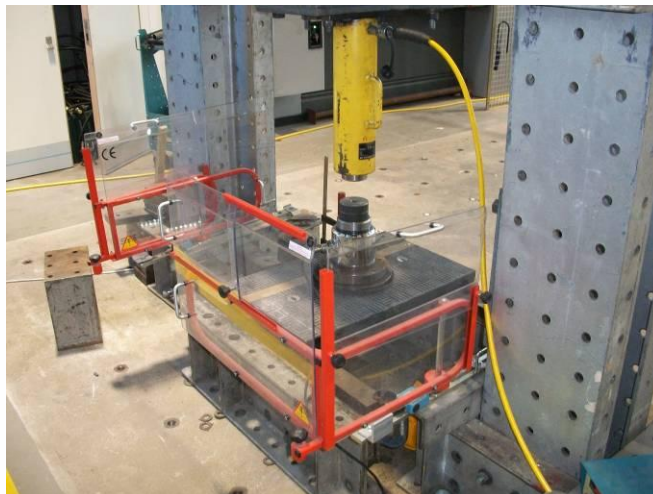
Photo. 2

The test rig consists of a 'giant mecano' frame bolted to the floor and supporting the Enerpac 50 ton hydraulic cylinder. (Photo 2)

The panel was supported on steel channels with two 65mm wide x 50mm deep steel bars at each end leaving a span of 566mm.

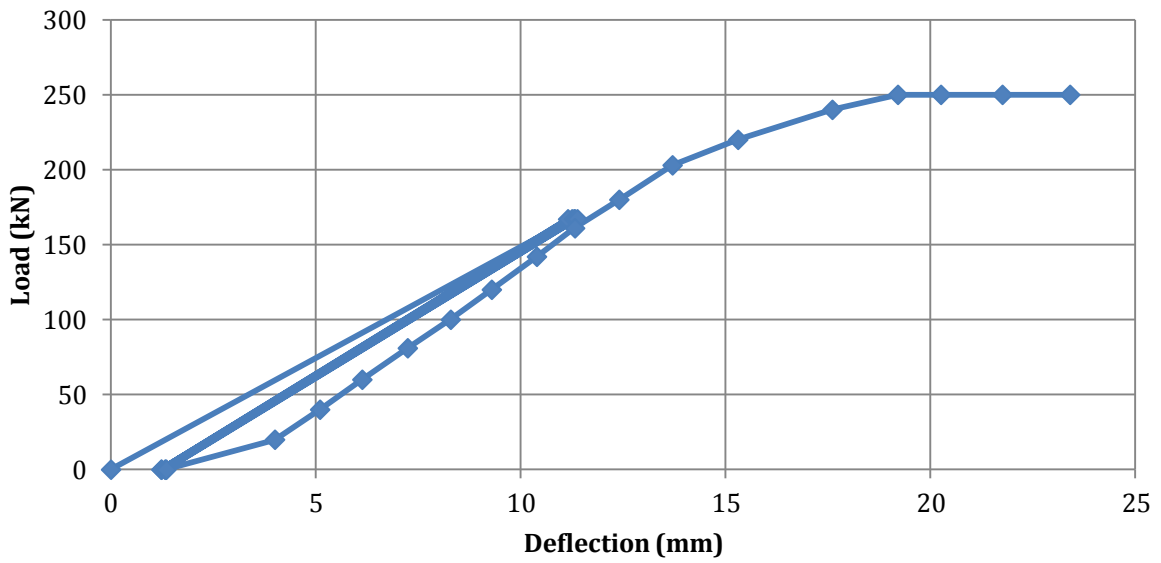
### Trench Panel EN124 C250 Test

LOAD (kN)	DEFLECTION (mm)	REMARKS
0	0.00	
167	11.25	
0	1.23	
167	11.15	
0	1.23	
167	11.30	
0	1.32	
167	11.32	
0	1.33	
167	11.38	
0	1.35	
20	4.00	
40	5.10	
60	6.13	
81	7.24	
100	8.29	
120	9.29	
142	10.39	
161	11.32	
180	12.40	Light cracking noises.
203	13.70	
220	15.30	
240	17.60	Light cracking/tearing noises from here on.
250	19.20	
250 (10 seconds)	20.25	
250 (20 seconds)	21.75	
250 (30 seconds)	23.40	<b>PASS</b>
0	3.70	
255	Dial gauge removed.	Ultimate failure - no more load and louder cracking/tearing noises.

**In accordance with EN124 Clause 8.3.1 the permanent set of the panel was 1.35mm which is within the permissible stated in Table 8 of the standard. ( $1/300 \times 448 = 1.49\text{mm}$ ).**

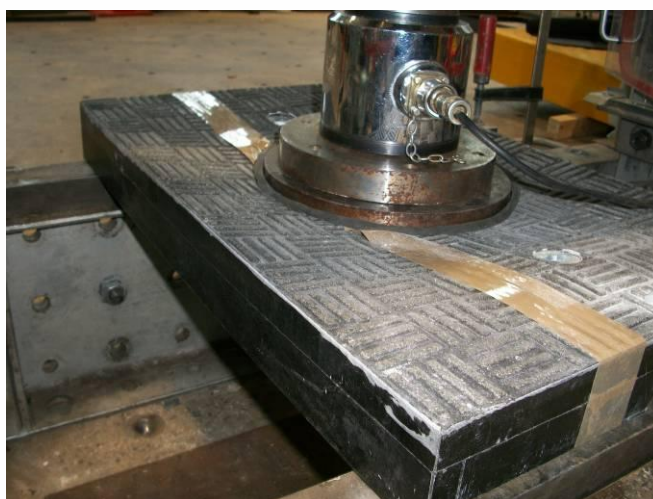
Photo.3

The panel was then loaded further up to failure which occurred at 255kN. (Photo.3)

The only visible damage to the trench panel that could be seen when it was removed from the test rig was some deformation to both the top and bottom faces.
