TEST REPORT

1710 x 600 x 200 Composite Trench Panel BS EN124 C250 Test

Document reference number - FIB-1710-600-200-30-07-15

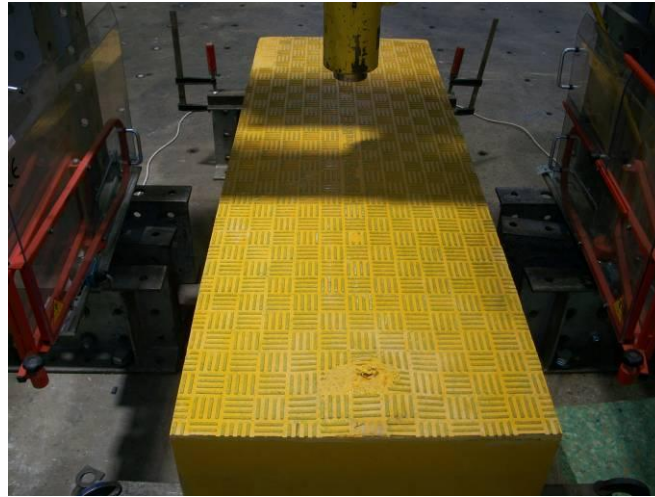
Photo. 1

The panel supplied for testing is a 1710mm long x 600mm wide x 200mm deep composite trench panel. (Photo.1)

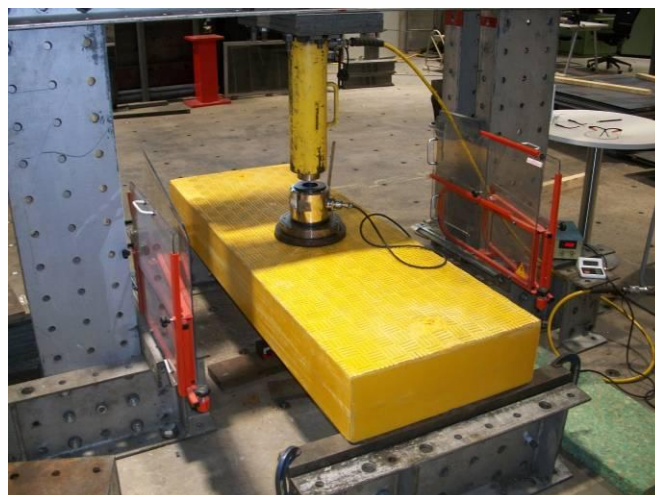
Photo. 2

The test rig consists of a 'giant mecano' frame bolted to the floor and supporting the Enerpac 50 ton hydraulic cylinder. (Photo 2)

The panel was supported on steel channels with two 65mm wide x 50mm deep steel bars at each end leaving a span of 1610mm.

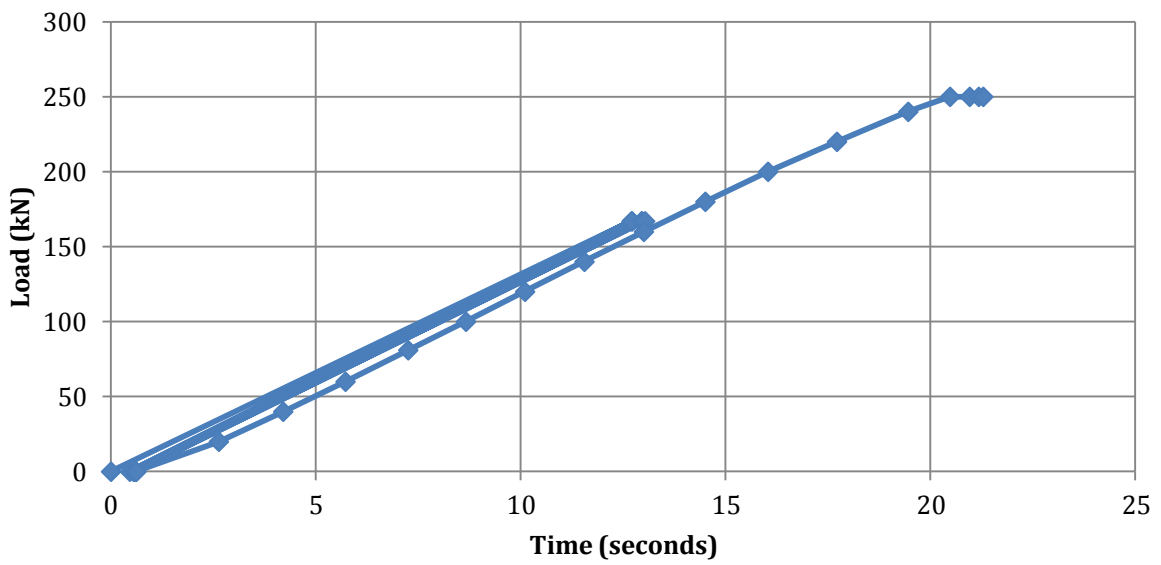
Yellow Trench Panel C250 Test

LOAD (kN)	DEFLECTION (mm)	REMARKS
0	0.00	
167	12.71	Some light racking noises from about 100kN just for the 1 st cycle.
0	0.46	
167	12.70	
0	0.55	
167	12.95	
0	0.58	
167	12.95	
0	0.60	
167	13.03	
0	0.62	
20	2.63	
40	4.20	
60	5.72	
81	7.25	
100	8.66	
120	10.10	
140	11.55	
160	13.00	
180	14.50	
200	16.03	
220	17.71	
240	19.45	
250	20.47	
250 (10 seconds)	20.95	
250 (20 seconds)	21.17	
250 (30 seconds)	21.28	PASS
0	1.01	
315	Dial gauge removed.	Louder cracking noises. Loading pad pushing into top face.
332	-	Loud bang and large crack on top face - Failure.

In accordance with EN124 Clause 8.3.1 the permanent set of the panel was 0.62mm which is within the permissible stated in Table 8 of the standard. ($1/300 \times 600 = 2.00\text{mm}$).

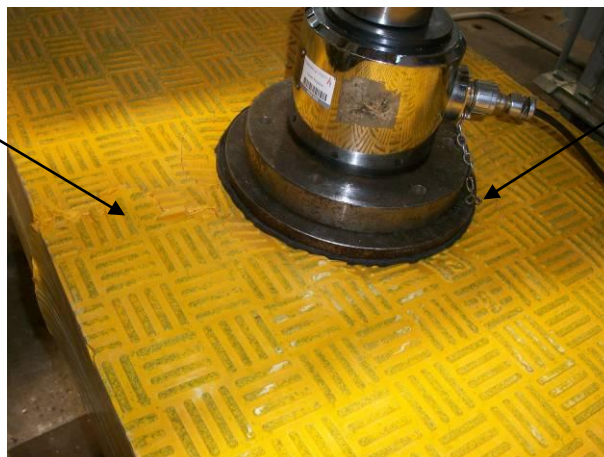
Photo.3

The panel was then loaded further up to failure which occurred at 332kN. (Photos.3 & 4)

Large crack

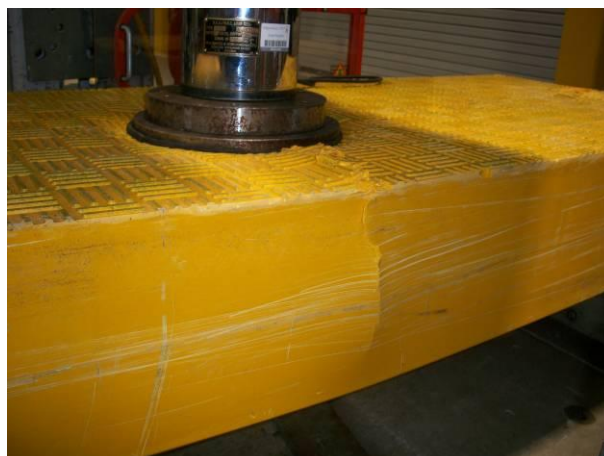
Photo.4

Pad pushing into face
