# TEST REPORT

**FS12-60-2-LD Trench Panel**  
**BS EN124 B125 Test**  
**Span - 205mm**

Document reference number - FIB-FS12-60-2-LD-B125-07-12-16

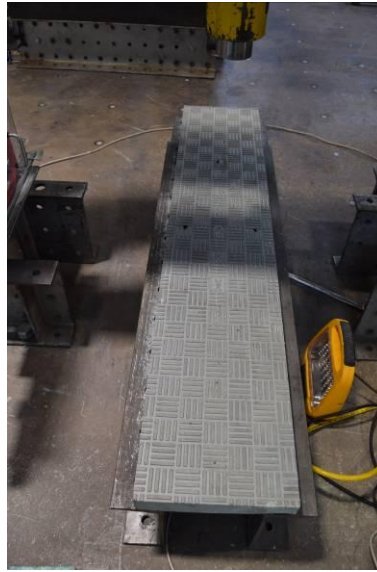
Photo. 1

The composite trench panel supplied is a rectangular FS12-60-2-LD (Photo.1)

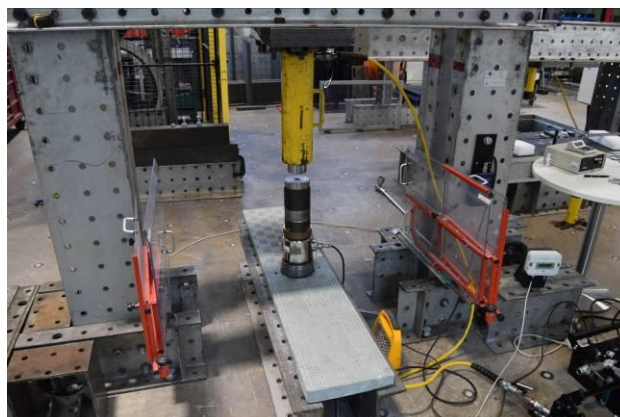
Photo.2

The test rig consists of a 'giant mecano' frame bolted to the floor and supporting the Enerpac 50 ton hydraulic cylinder.

The trench panel sat directly on two steel channels supported on its longest sides at a span of 205mm.

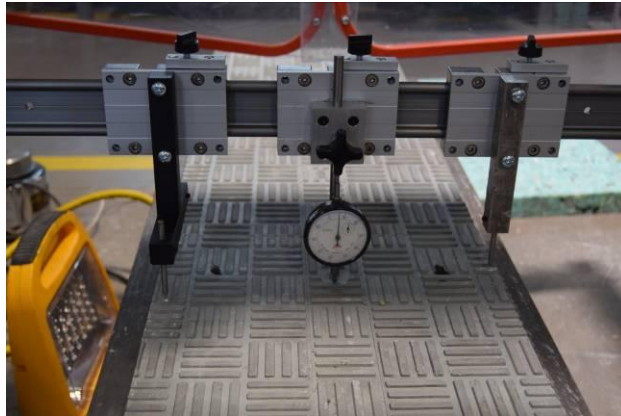
Photo.3

Photograph 3 below shows the initial reading being taken for the permanent set test.

Initial Reading	0.00mm
Reading after 5 cycles	0.15mm
<b>Permanent Set</b>	<b>0.15mm</b>

Permissible permanent set for a B125 test is  $\frac{CO}{100} = \frac{304}{100} = 3.04\text{mm}$

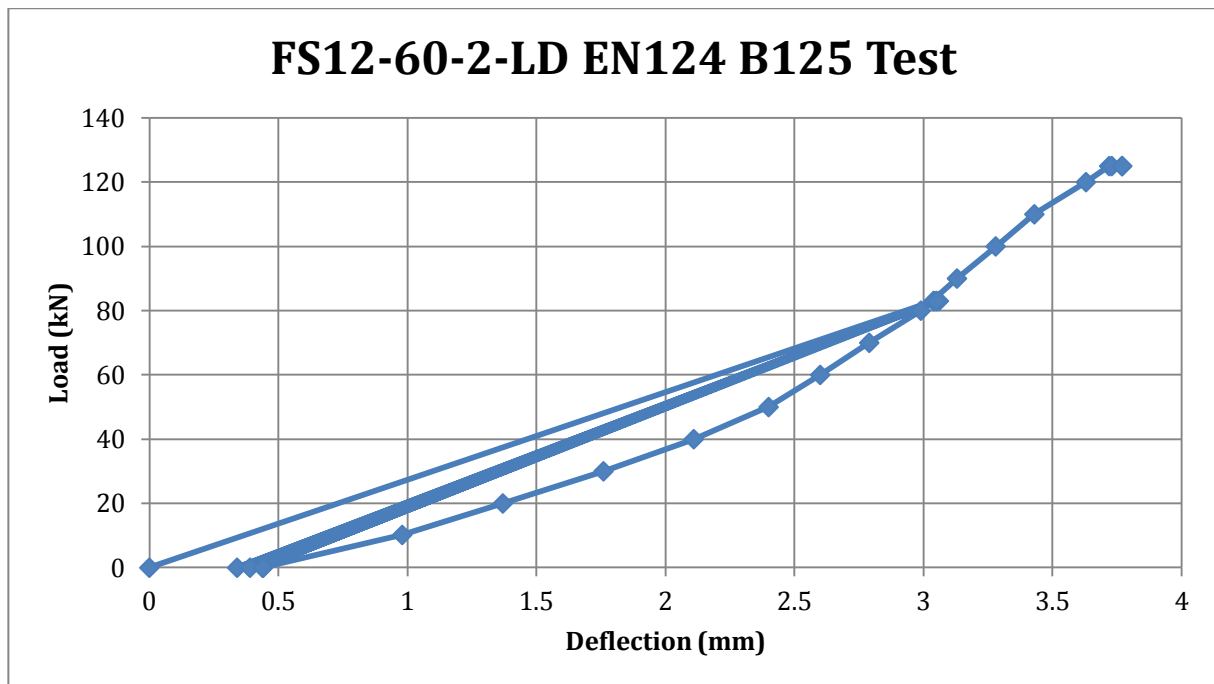
LOAD (kN)	DEFLECTION (mm)	REMARKS
0	0.00	
83	3.04	
0	0.34	
83	3.04	
0	0.39	
83	3.06	
0	0.44	
83	3.05	
0	0.44	
83	3.05	
0	0.44	
10.2	0.98	
20	1.37	
30	1.76	
40	2.11	
50	2.40	
60	2.60	
70	2.79	
80	2.99	
90	3.13	
100	3.28	
110	3.43	
120	3.63	
125	3.72	
125 (10 seconds)	3.73	
125 (20 seconds)	3.77	
125 (30 seconds)	3.77	<b>PASS</b>
0	0.49	
168	Gauge removed	Loud cracking and banging and load dropping off. Failure

**The panel held the test load of 125kN for the required 30 seconds so therefore passed the load bearing test.**

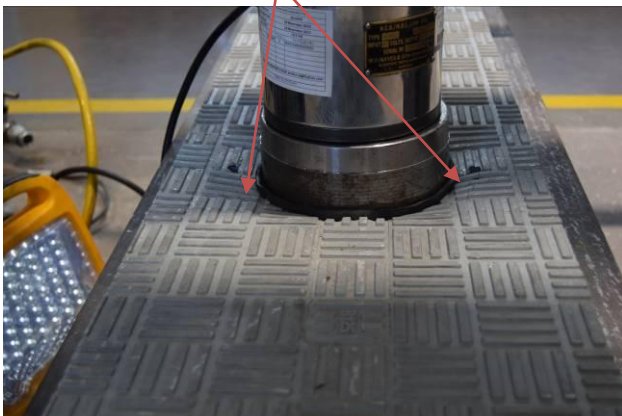
Photo.4

Photograph 4 below shows the panel still in the test rig at the failure load of 168kN. The top face was badly deformed under and around the loading pad, with some cracking around the outer edges of the pad.

Deformed and cracks

After the panel had passed the EN124 B125 load bearing test the linear potentiometer was removed from under the cover to avoid damage. The panel was then loaded further until ultimate failure occurred at 168kN.

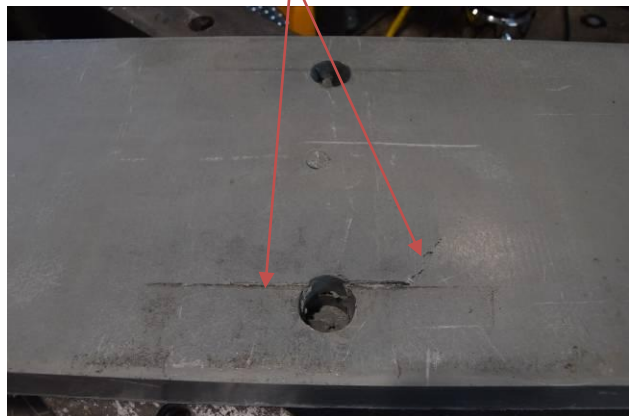
Photo.5

On the underside there was a large crack around the centre of the panel at the edge of the support. (Photo.5)

Large crack
