Newcastle Train Station, UK

Fibrelite On Track with Lightweight, Composite Trench Covers for a Major UK Rail Station's Platforms

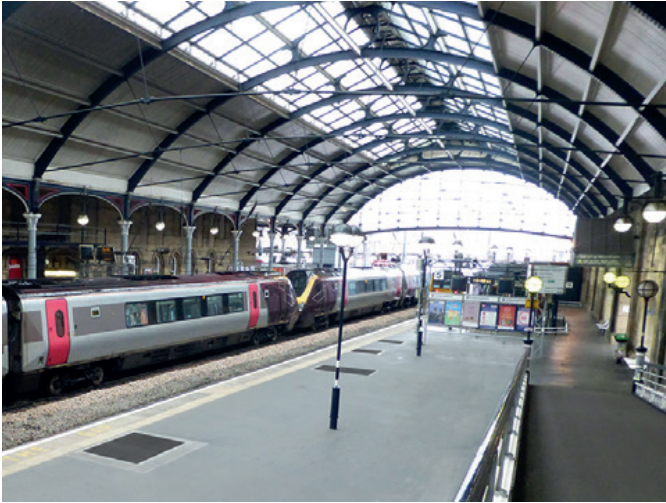
Fibrelite covers feature an anti-slip surface

Fibrelite solved the manual handling issues by designing lightweight, composite trench covers in bespoke sizes, supplied complete with aluminium frames. These larger sizes allowed for fewer panels to be used to cover the openings, reducing overall cost of replacement, while still remaining light enough for easy and safe manual handling. Fibrelite's composite trench covers offer the best strength to weight ratio in the industry, easily achieving the BS EN124 B125 load rating required for this application. In addition to this, Fibrelite covers come as standard with an anti-skid finish, a major consideration in a rail platform environment.

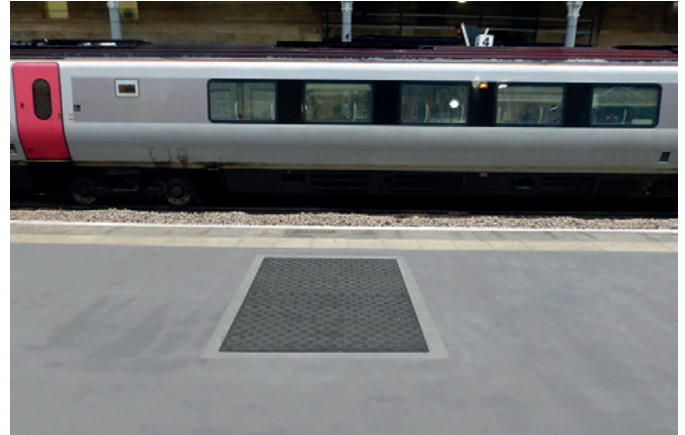
Lightweight Fibrelite covers now installed on platform

Fibrelite has recently developed a range of bespoke, lightweight, composite trench covers, dramatically reducing the cost to cover larger openings. These bespoke covers have recently been installed over access hatches in the platform of a major UK rail station to give quick and easy access to services below platform level.

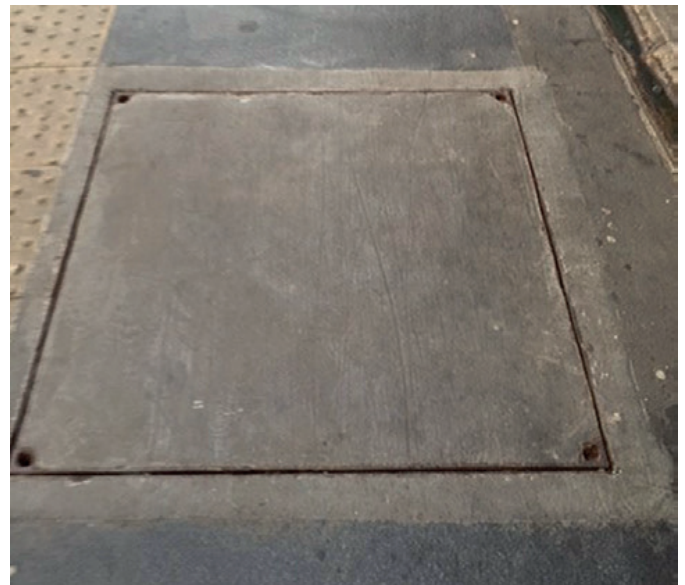
Previously installed, heavy, difficult to lift concrete covers

The covers on the platform provide essential access to services housed below the platform level and are lifted regularly, so routine maintenance work can be carried out. The previously installed covers were heavy, concrete infilled covers which proved very difficult to remove and presented serious manual handling issues to operatives. Removing the covers was a costly and time consuming process, with specialist lifting equipment often required.
