# TEST REPORT

## FL100 Composite Cover and Frame BS EN124 C250 Test

Document reference number - FIB-FL100-19-01-16

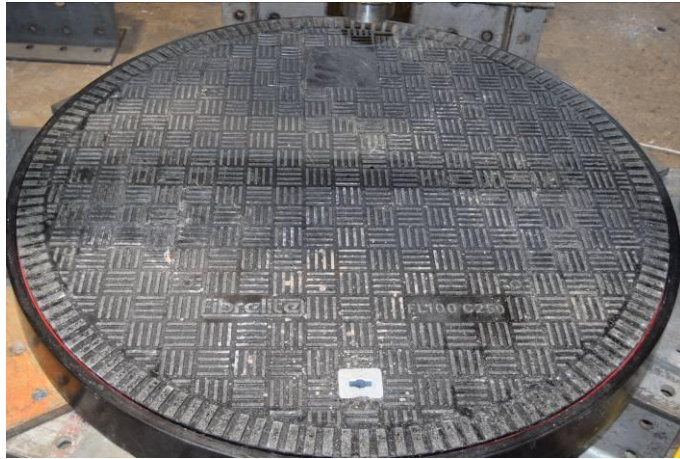
Photo. 1

A composite frame was supplied with the cover.

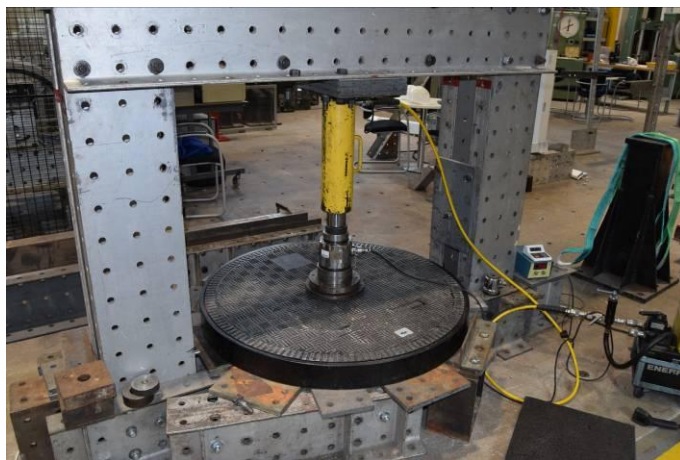
Photo. 2

The test rig consists of a 'giant mecanno' frame bolted to the floor and supporting the Enerpac 50 ton hydraulic cylinder. (Photo 2)

The frame sat on steel channels with steel shims to pack and level.
