## **TEST REPORT**

### **FL100 EN124 D400 Cover Test**

Date: 12/09/12

**Client: Fibrelite Composites Ltd.**

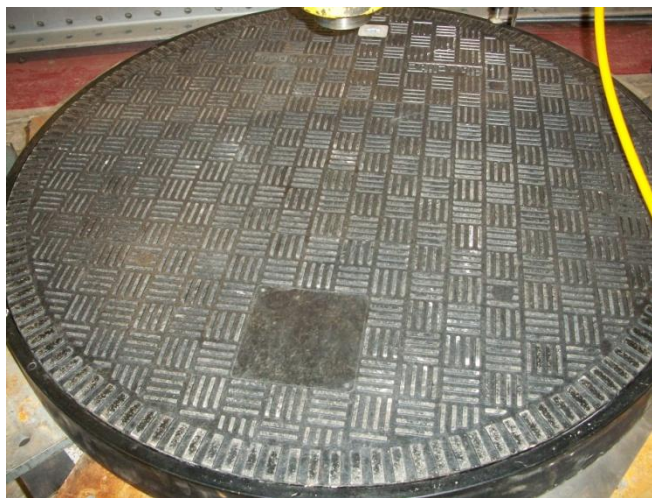
Photo. 1

The cover supplied is a round FL100 and of composite construction. (See photo. 1)  
No. on cover –

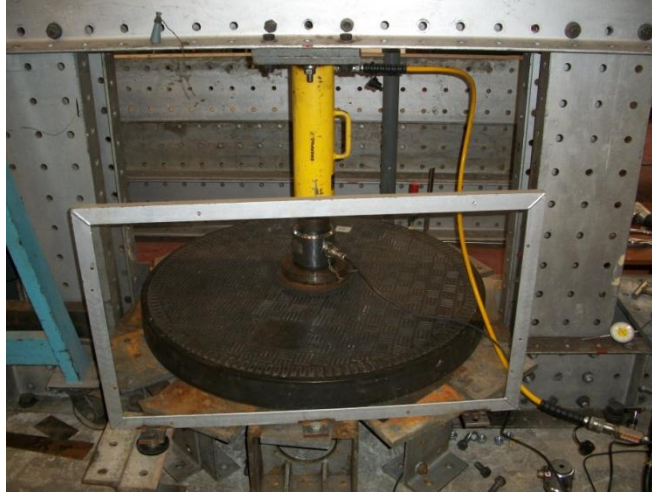
Photo. 2

The test rig consists of a 'giant mecano' frame bolted to the floor and supporting the Enerpac 50 tonne hydraulic cylinder. (Photo 2)
