TEST REPORT

FL180 EN124 C250 Cover Test

Date: 22/03/13

Client: Fibrelite Composites Ltd.

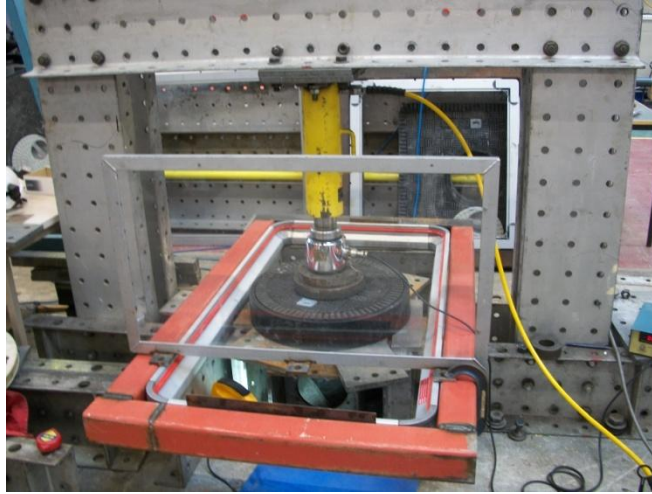
Photo. 2

The test rig consists of a 'giant mecano' frame bolted to the floor and supporting the Enerpac 50 tonne hydraulic cylinder. (Photo 2)
