## **TEST REPORT**

### **FL180 B125 Cover Test**

**Client: Fibrelite Composites Ltd.**

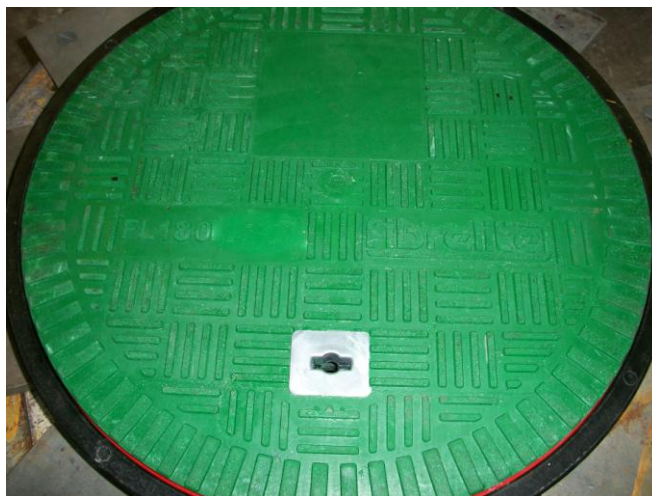
Photo. 1

The cover supplied is a round FL180 and of composite construction. (See photo. 1)  
No. on cover – 2988 180

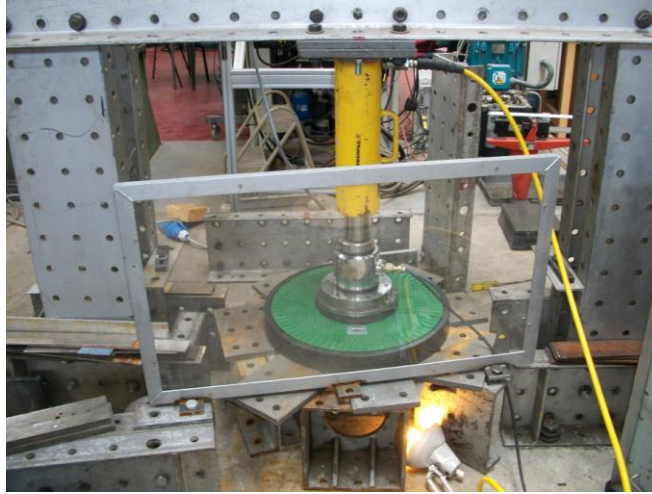
Photo. 2

The test rig consists of a 'giant mecano' frame bolted to the floor and supporting the Enerpac 50 tonne hydraulic cylinder. (Photo 2)

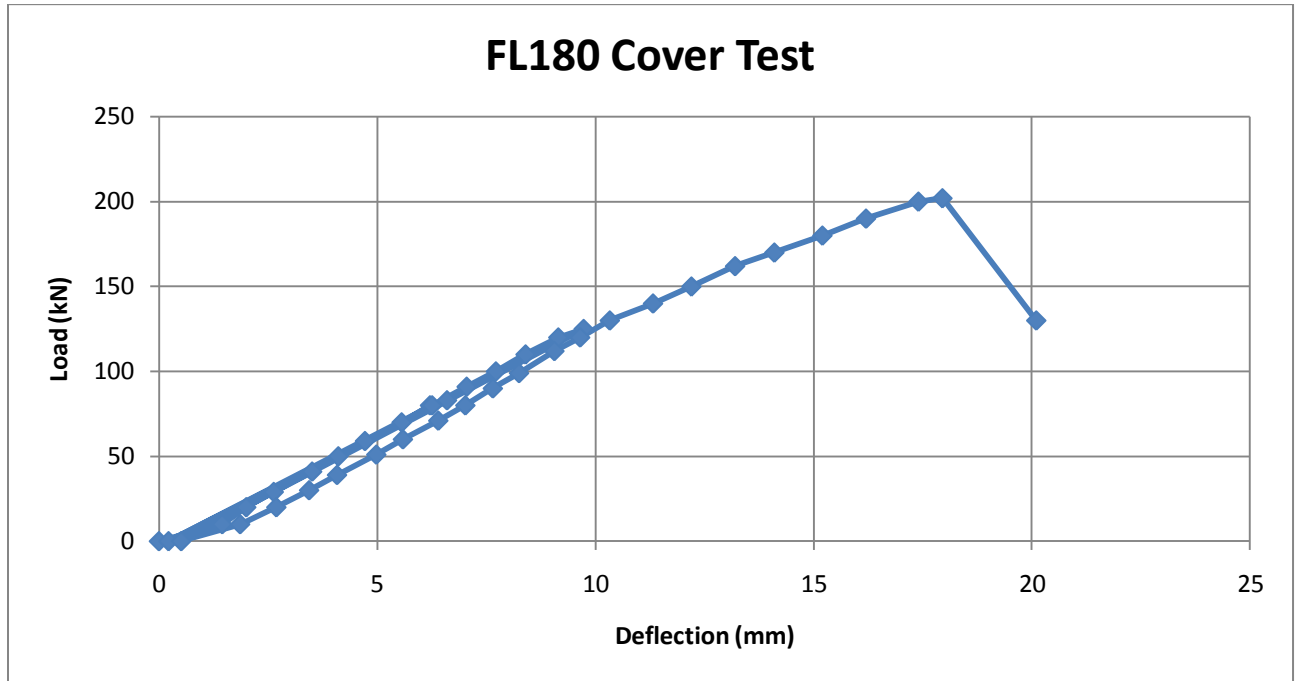
**The permanent set at 83kN (2/3 test load) was 0.22mm.**

**The permanent set at 125kN (test load) was 0.51mm.**

**The cover failed at 202kN.**
