# TEST REPORT

## FL600/D400 Composite Cover and Frame BS EN124 D400 Test

Document reference number - FIB-FL600-13-05-15

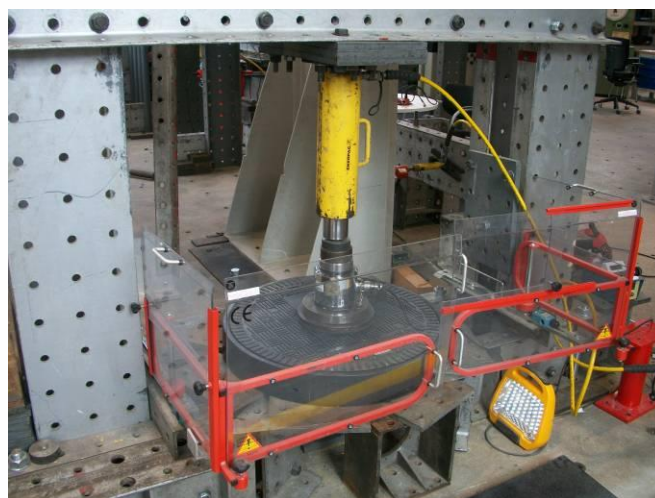
Photo. 2

The test rig consists of a 'giant mecano' frame bolted to the floor and supporting the Enerpac 50 ton hydraulic cylinder. (Photo 2)
