## **TEST REPORT**

### **FL760 Cover Test to EN124 C250**

Date: 19/06/09

**Client: Fibrelite Composites Ltd.**

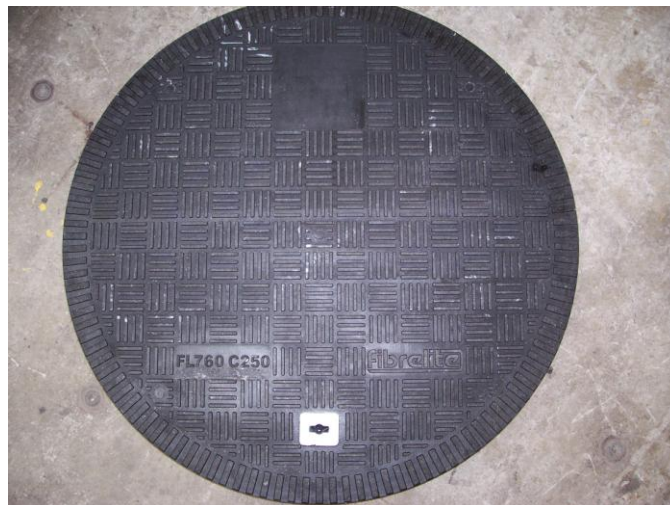
Photo.1

The cover supplied is a Fibrelite FL760 (Photo.1)  
No. on cover – 09 4504 760

The cover was also supplied with a new composite frame for it to sit in.  
Frame No. – 094007 760F
