TEST REPORT

FL90 B125 Cover Test

Date: 14/04/11

Client: Fibrelite Composites Ltd.

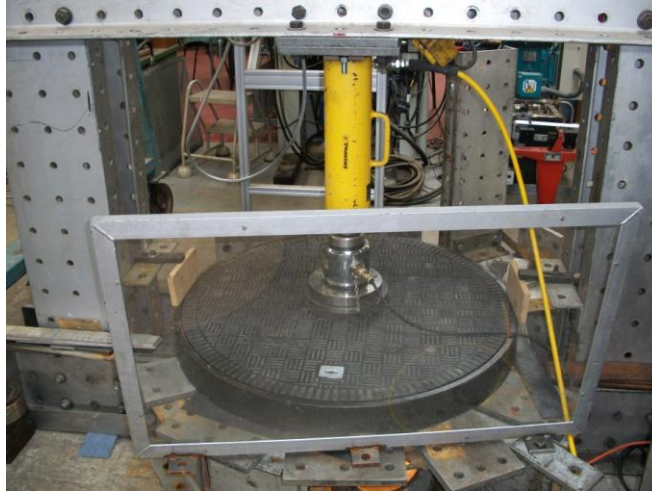
Photo. 2

The test rig consists of a 'giant mecano' frame bolted to the floor and supporting the Enerpac 50 tonne hydraulic cylinder. (Photo 2)
