TEST REPORT

FM45 EN124 D400 Test

Date: 02/11/11

Client: Fibrelite Composites Ltd.

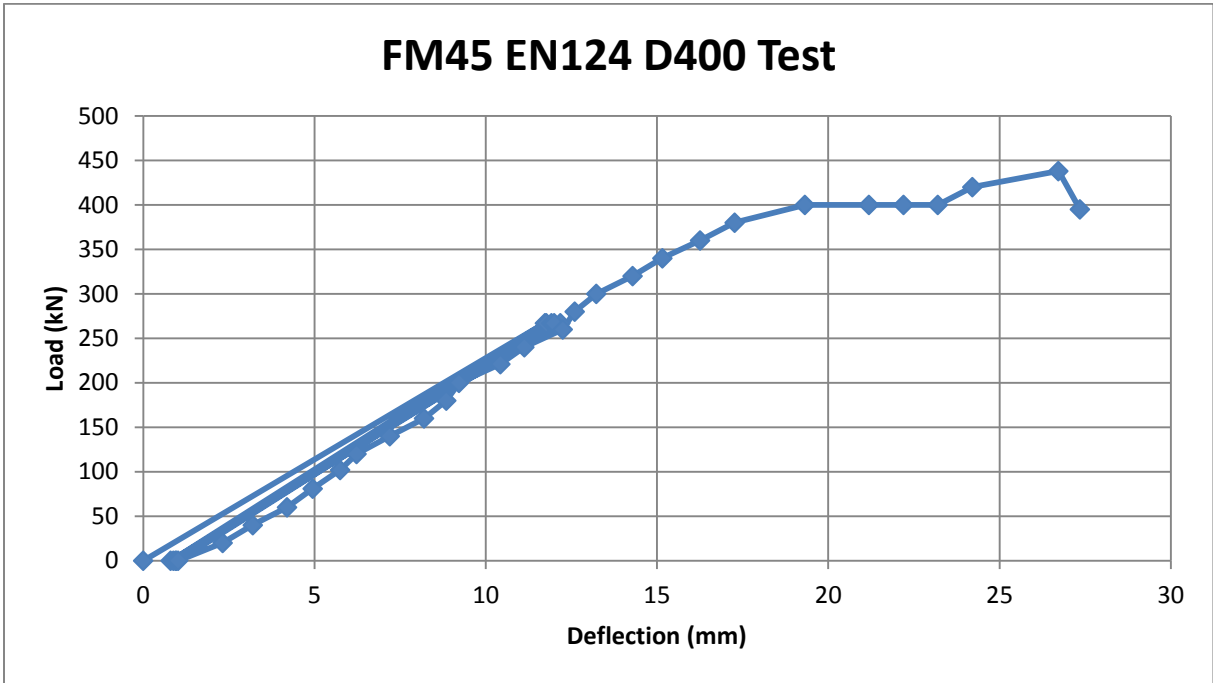
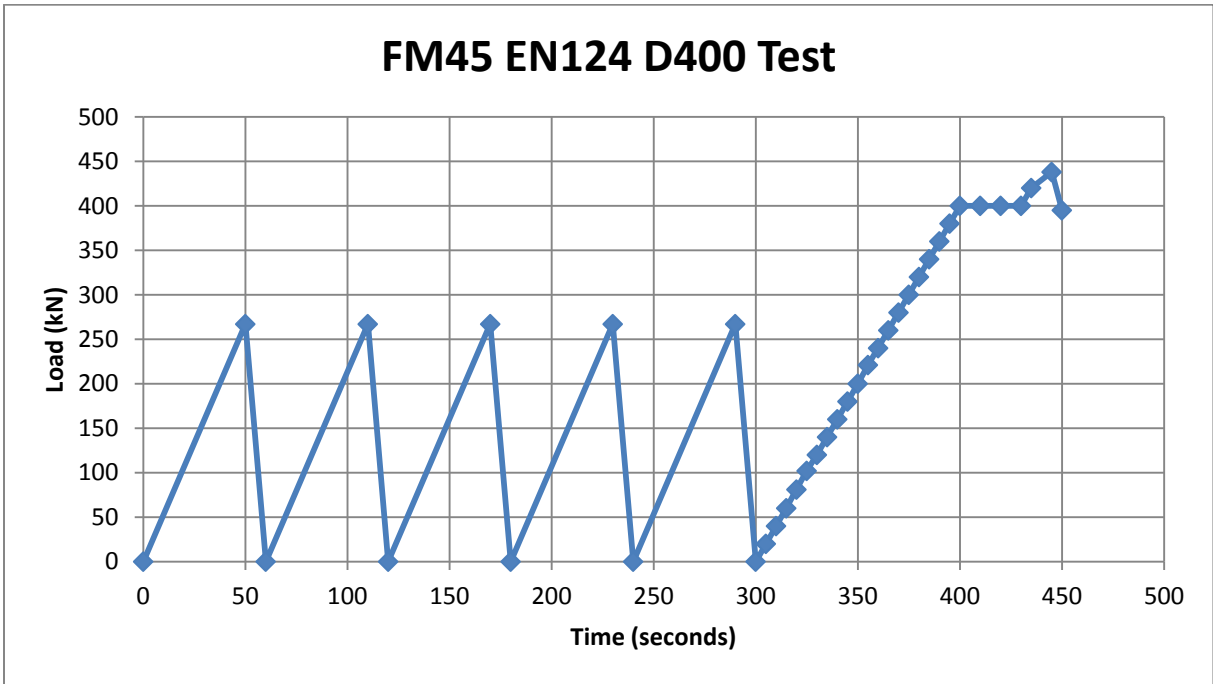
Load (kN)	Deflection (mm)	Remarks
0	0.00	
267	11.73	Light cracking noises from 140kN onwards for the 1 st cycle.
0	0.80	
267	12.18	
0	0.88	
267	11.77	
0	0.94	
267	11.92	
0	0.97	
267	12.00	
0	1.02	
20	2.32	
40	3.20	
60	4.20	
81	4.95	
102	5.75	
120	6.23	
140	7.20	
160	8.20	
180	8.85	
200	9.22	
221	10.43	
240	11.13	
260	12.25	
280	12.60	
300	13.23	
320	14.29	
340	15.16	
360	16.26	
380	17.27	
400	19.32	
400 (10 seconds)	21.19	
400 (20 seconds)	22.20	
400 (30 seconds)	23.20	
420	24.21	Louder cracking noises
438	26.72	Failure – loud cracking
395	27.35

In accordance with EN124 Clause 8.3.1 the permanent set of the cover was 1.02mm which is within the permissible stated in Table 8 of the standard. ($1/300 \times 315 = 1.05\text{mm}$).

The cover therefore passed the EN124 D400 test for both permanent set and load.

The cover finally failed at 438kN with a number of cracking and banging noises and the cover unable to take any more load.
