## **TEST REPORT**

### **FM45 EN124 A15 Test**

Date: 27/04/12

**Client: Fibrelite Composites Ltd.**

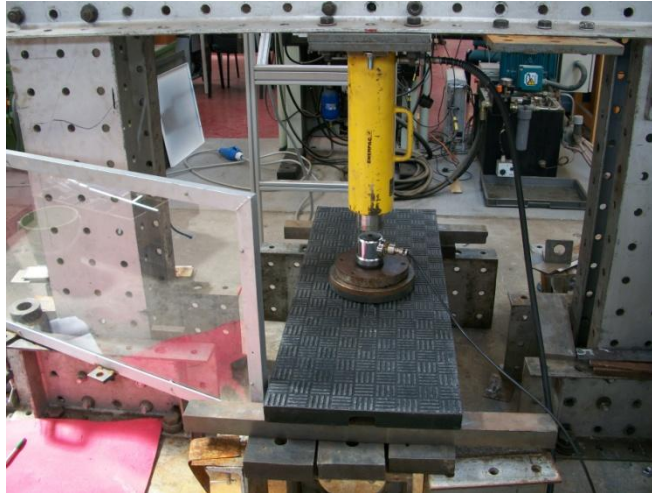
Photo. 2

The test rig consists of a 'giant mecano' frame bolted to the floor and supporting the Enerpac 50 tonne hydraulic cylinder. (Photo 2)
