TEST REPORT

FM45-B125SH-120 Trench Panel EN124 B125 Test

Date: 29/04/13

Client: Fibrelite Composites Ltd.

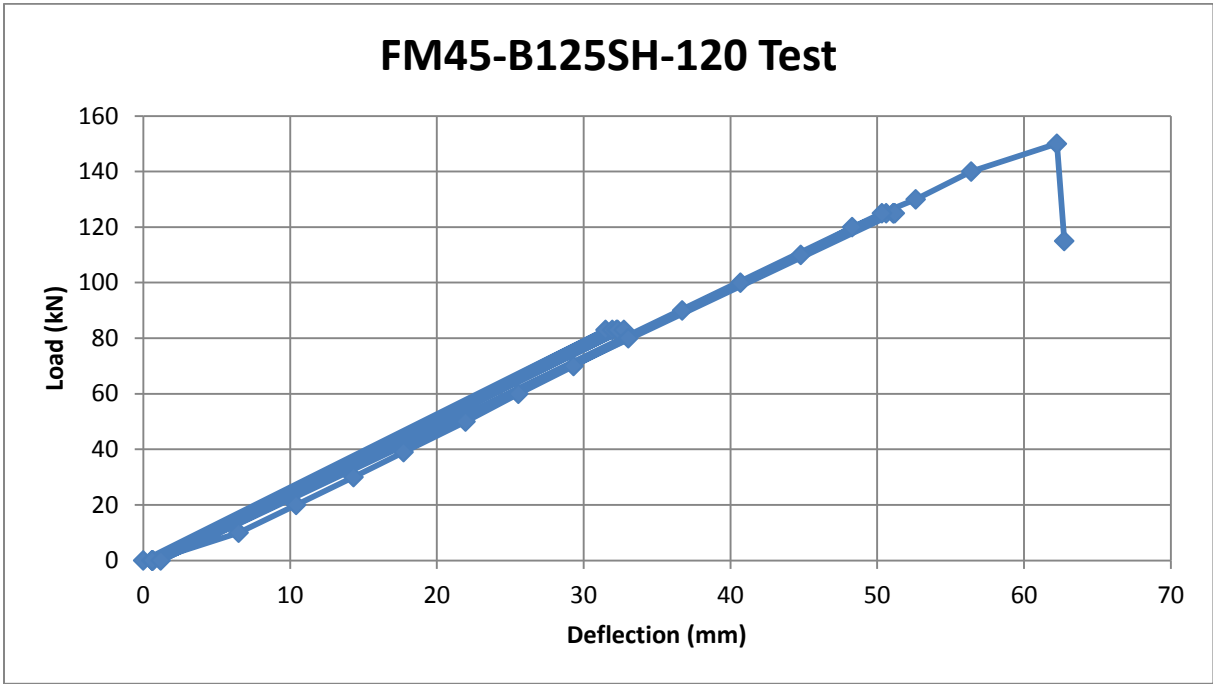
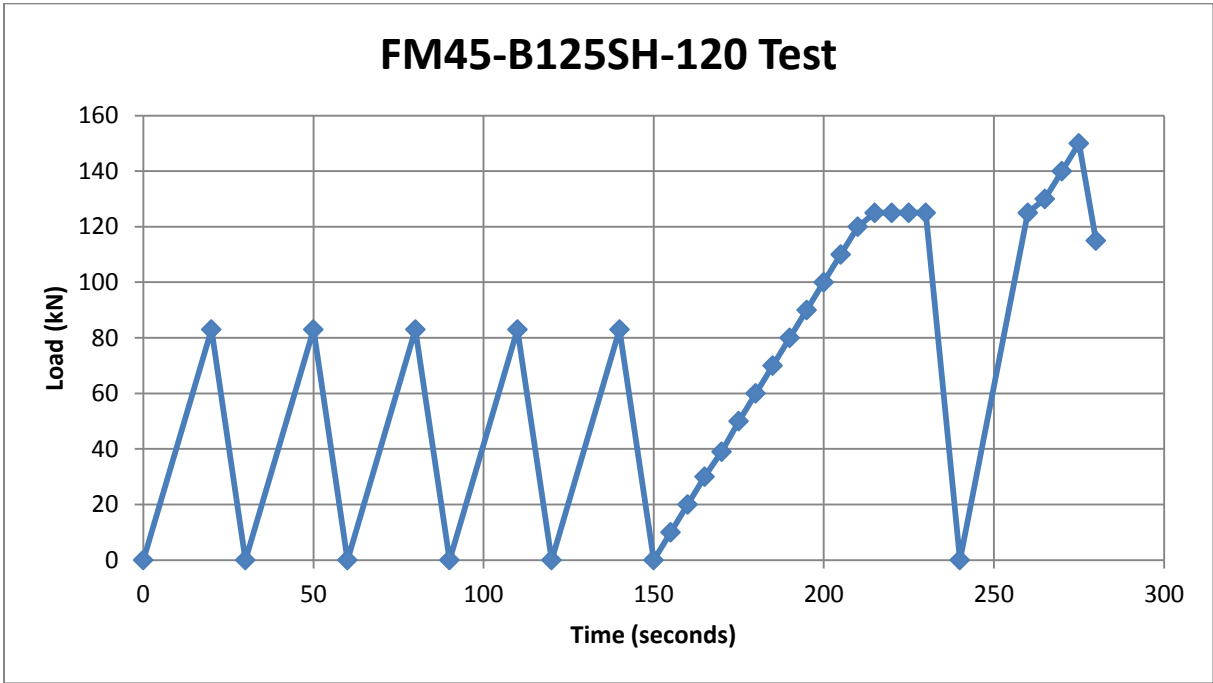
The panel was then loaded again to achieve failure which occurred at 150kN.

Photographs 3 and 4 show a large crack on the top face of the panel at failure.
