# Cloud Computing Facility, Hong Kong

## Hi-Tech Composite Covers for High-Tech Cloud Computing Facility in Hong Kong

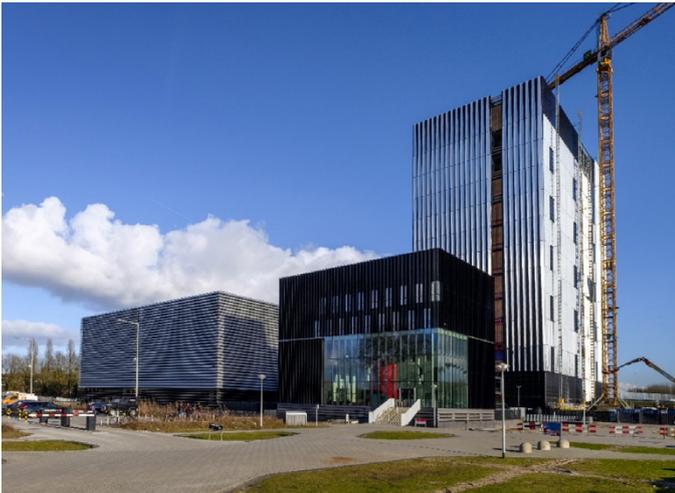
Fibrelite trench covers protect fibre optic cabling at emergency vehicle access point (image used for illustration purposes as actual data centre cannot be shown)

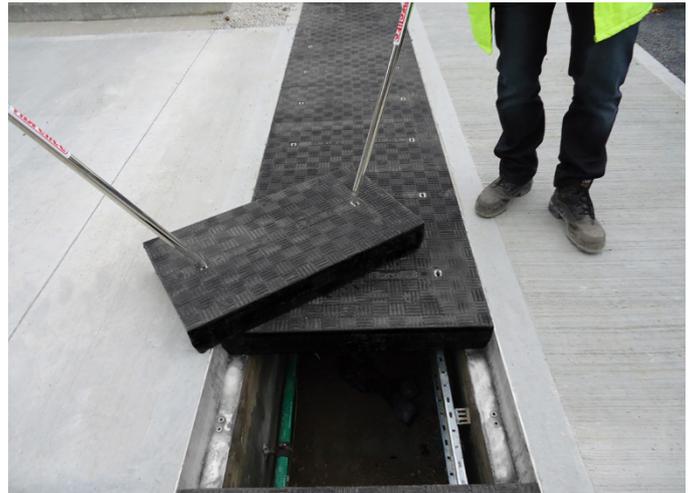
Fibrelite covers are designed to withstand heavy loads and harsh weather conditions for many years (Image of a similar installation used for illustration purposes as actual data centre cannot be shown)

The specified Fibrelite heavy-duty trench covers have a 40-tonne load rating (D400), enabling them to withstand heavy vehicle traffic whilst still being able to outperform concrete on a long-term basis. Designed as a fit and forget product all Fibrelite GRP composite covers are maintenance free corrosion-resistant and ultra-durable.
